Investigation Report 2011-R006

**Road vehicle struck at level crossing XM096,
County Roscommon,
2nd September 2010**

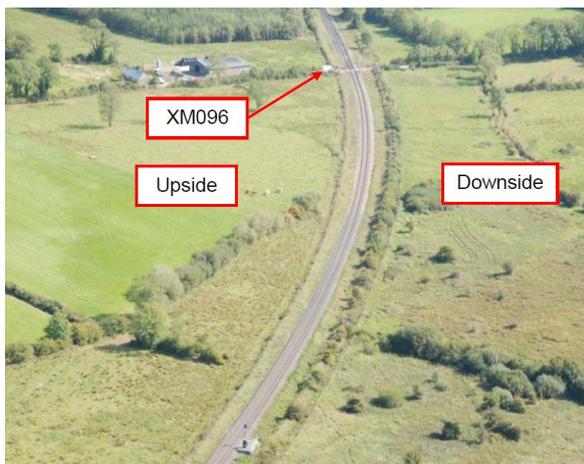
Photograph 1 – Aerial view of XM096

XM096 is located at 103 miles 400 yards on the Athlone to Westport line as measured from Broadstone Station in Dublin. It is situated in the townland of Island Upper outside the town of Roscommon in County Roscommon. XM096 is an occupation on public road (OP) type LC. This means that it is situated on a public road and has manually operated gates that are opened and closed by the LC user, which are normally kept closed across the road. As with all passive LCs operated by the LC user, the LC users at OP LCs determine when it is safe to cross. An aerial view of XM096 and its approaches is shown in Photograph 1.

XM096 is located on a cul de sac with the access road approaching from the Up side of the track, see Photograph 1. There is one dwelling on the Down side of the railway at XM096 that is used as a holiday home. XM096 is also on the walking route for the Suck Valley Way, which crosses the railway line at several LCs in the area (National Trails Office, undated), and it allows access to the river Suck for fishing.

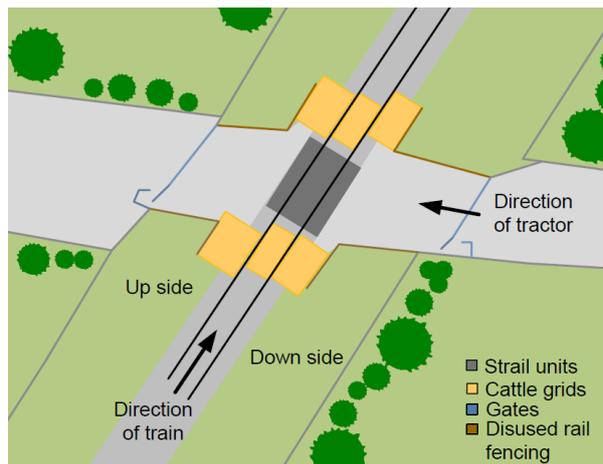
Figure 2 – Layout of XM096

XM096 crosses the railway line at an obtuse angle, see Figure 2. The surface of the approach road is an unsealed gravel road. The surface directly outside the rails and between the rails consists of Strail units, which are made of rubber. There are cattle grids the full width of XM096 on the railway approaches to prevent cattle straying along the railway line.

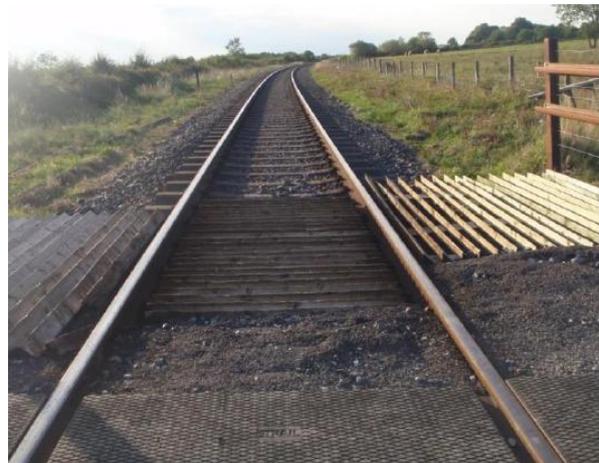
Photograph 3 – Direction train approached from

The direction the train was travelling from is shown in Photograph 3.

As the Farmer had passed the viewing position on the Down side of the track when the train came into view, the view from either side of the track was not relevant to his actions. The view from the centre of XM096 is shown in Photograph 3. The Farmer's view of an approaching train may have been obscured by vegetation on the side of the track along the curve on the railway approach to XM096, see Photograph 5.

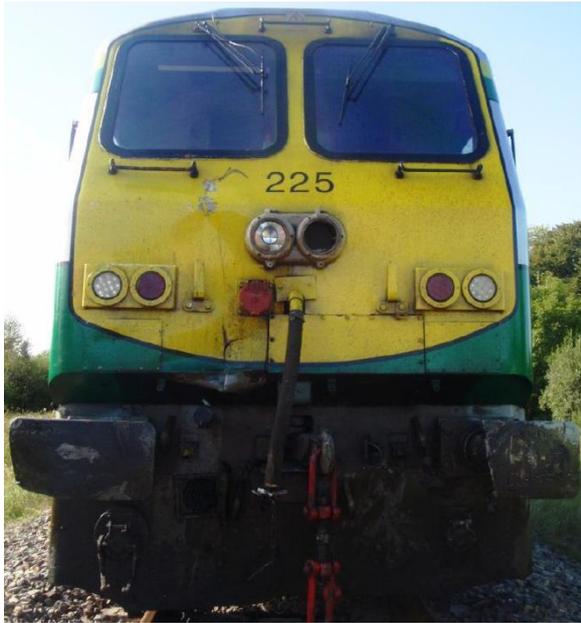
Photograph 6 – Front of locomotive 225

Locomotive 225 is a Class 201 locomotive, these were manufactured by General Motors and entered service in 1994. They have a mass of 112,000 kg and a maximum speed of 161 km/h. They are 20.9 m long. The front of locomotive 225 is shown in Photograph 6.
