**Report into the derailment of a Tara Mines freight train at Skerries on the**

**10<sup>th</sup> of January 2008**

**Report Number 08011001**

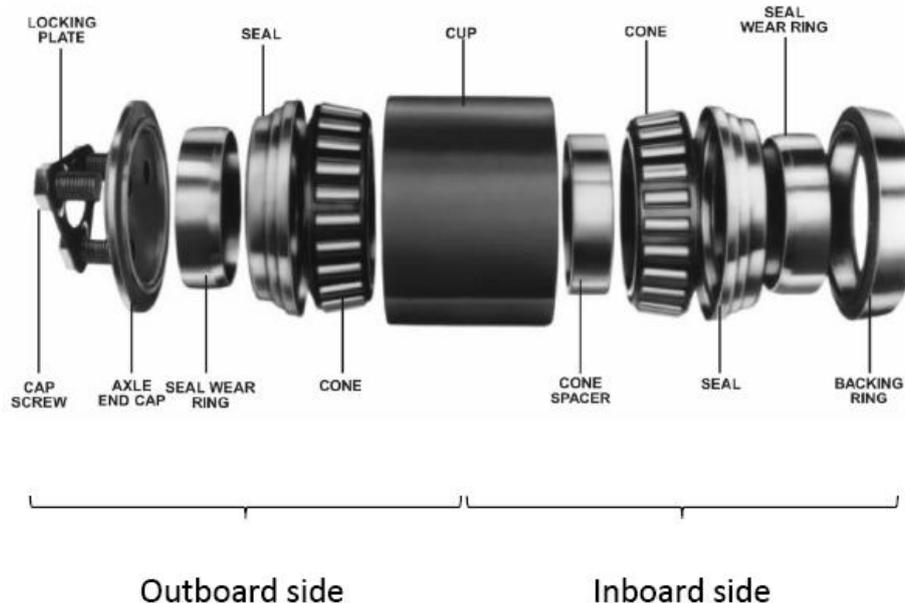
Figure 4 – Class D bearing components

The bearings fitted to the Y23 bogies are standard AP class D (5 ½ x 10) tapered roller bearings used throughout the world and in this case manufactured by British Timken<sup>2</sup>, see figure 4. The bearing assembly consists of an outer cup, two tapered roller bearing cone assemblies separated by a spacer, and two (inner and outer) grease seals with wear rings. The bearing assembly is pressed on to an axle journal and then retained by the end cap, which attaches to the end of the axle via three cap screws and a locking plate. Bearings are normally stamped around the cup with a component type number, serial number and the date of manufacture.
