Investigation Report 2010-R001

Collision of a Locomotive with Passenger Carriages at Plunkett

Station in Waterford on the Limerick to Rosslare Line

29th of March 2009

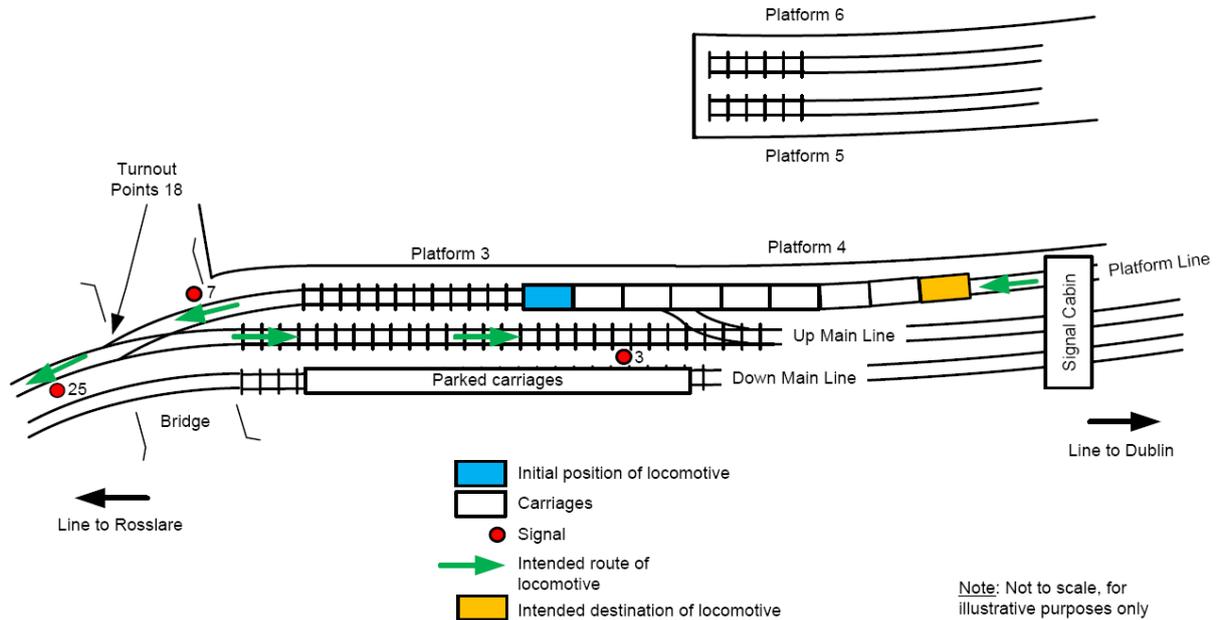
Figure 2 – Station layout

The locomotive was uncoupled from the carriages by a *shunter*. The locomotive was driven to the end of the platform from cab no. 2 and stopped beside signal no. 7, see figure 3. The train driver contacted the *signalman* in the Waterford Central Cabin by radio to request the route to allow the movement of the locomotive to the opposite end of the carriages (as illustrated in figure 2).

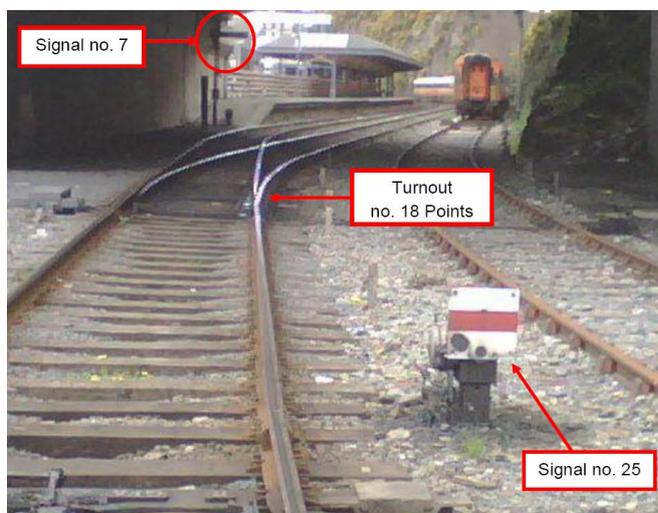
Photo 1 – Plunkett Station from Rosslare side

Plunkett Station is located at the 75 $\frac{3}{4}$ milepost measured from Mallow via Fermoy on the Limerick to Rosslare Line. The station is positioned on a curve. There is a road bridge over the railway line at the Rosslare end of the station. As the track passes under the road bridge the track starts to curve in the opposite direction. There is a rock face on the opposite side of the tracks from the station beside the Down Main Line. The Down Main Line is not used in normal train running and is used to store carriages. See figure 2 and photo 1.

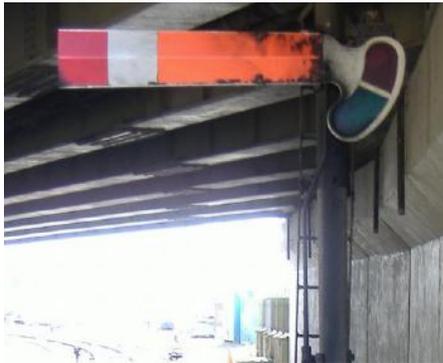
Photo 2 – Signal no. 7

The no. 7 signal is a *semaphore signal* positioned on the track at the Rosslare end of the Platform Line, see photo 2. The no. 25 signal is a mechanically operated *disc* on the ground between the Up Main Line and the Down Main Line, see photo 3. The no. 3 signal is a *colour light signal* suspended over the railway line between platforms 3 and 4.

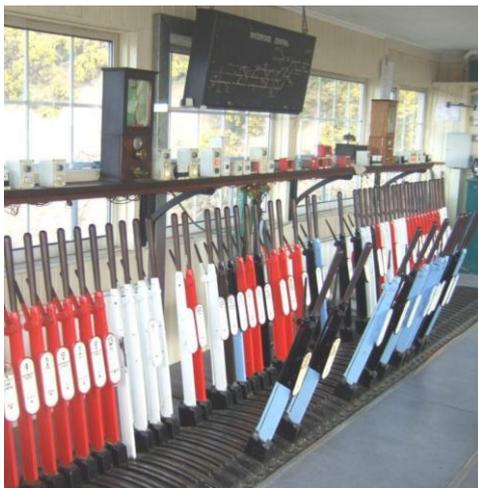
Photo 3 – Waterford Central Cabin

The signalman pulled the levers to set signals no. 25, 3 and 7 as well as pressing the buttons and moving the levers for points no. 39 and 40, see photo 3. This gave the train driver a proceed indication at signals no. 25 and 3.

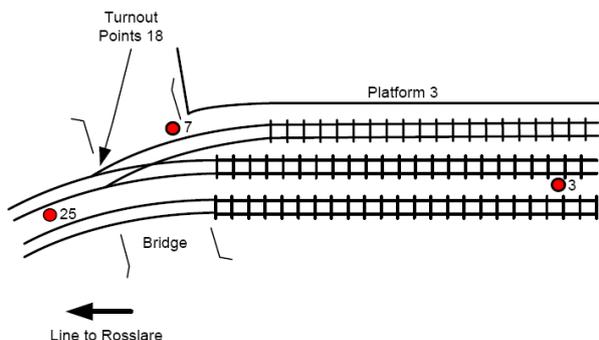
Figure 7 – Distances between elements

From signal no. 7 to signal no. 25 - 66 m
From no. 18 points to signal no. 25 - 14 m
From signal no. 25 to signal no. 3 - 244 m

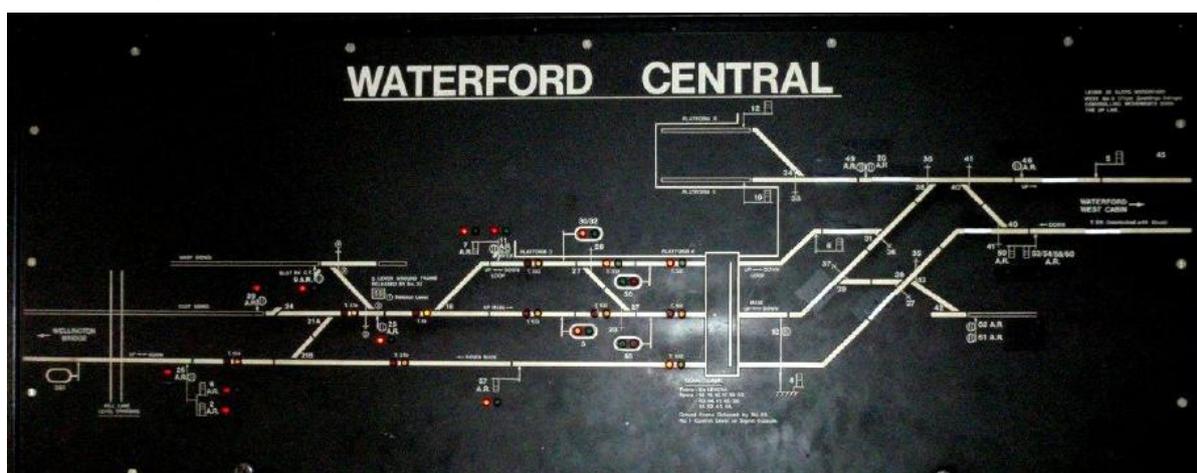
Photo 2 – Signal panel for Waterford Central Cabin

Waterford Central Cabin has a signal panel above the levers to assist the signalman to set routes and control movements in the station area, see photo 2. The panel has track circuit indicators and signal indicators that show red or green lights as indicated in table 1.
