Railway Accident Investigation Unit

INVESTIGATION REPORT

Collision of an ICR with a buffer stop at Laois Train Care Depot, 17th July 2018

RAIU Report No: 2019-R002

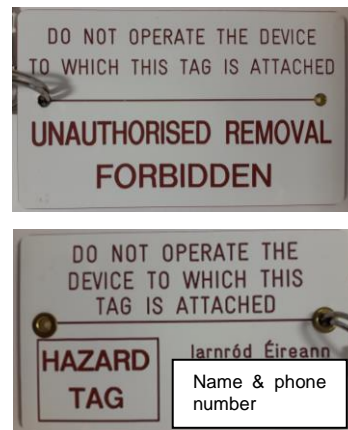
Figure 2 – Identification tags

- 1 On the 17th July 2018 ICR 16 was required to be shunted from Road 6B to Road 8 in LTCD to allow maintenance repairs to be carried. The LTCD Duty Manager appointed the Limited Shunter and the CME Driver (to act as the driver of ICR 16) to carry out these movements.
- 2 The Limited Shunter and the CME Driver checked the Day and Night Production Boards in the Duty Managers Office; noting that there were no restrictions against ICR 16. With this information, the Limited Shunter went out to ICR 16 and removed the “Not to be Moved” Board (Figure 1), which had remained on ICR 16 since it was last worked on, as there were no personal identification tags attached (Figure 2). It should be noted there was no restriction on the Limited Shunter from removing the board.

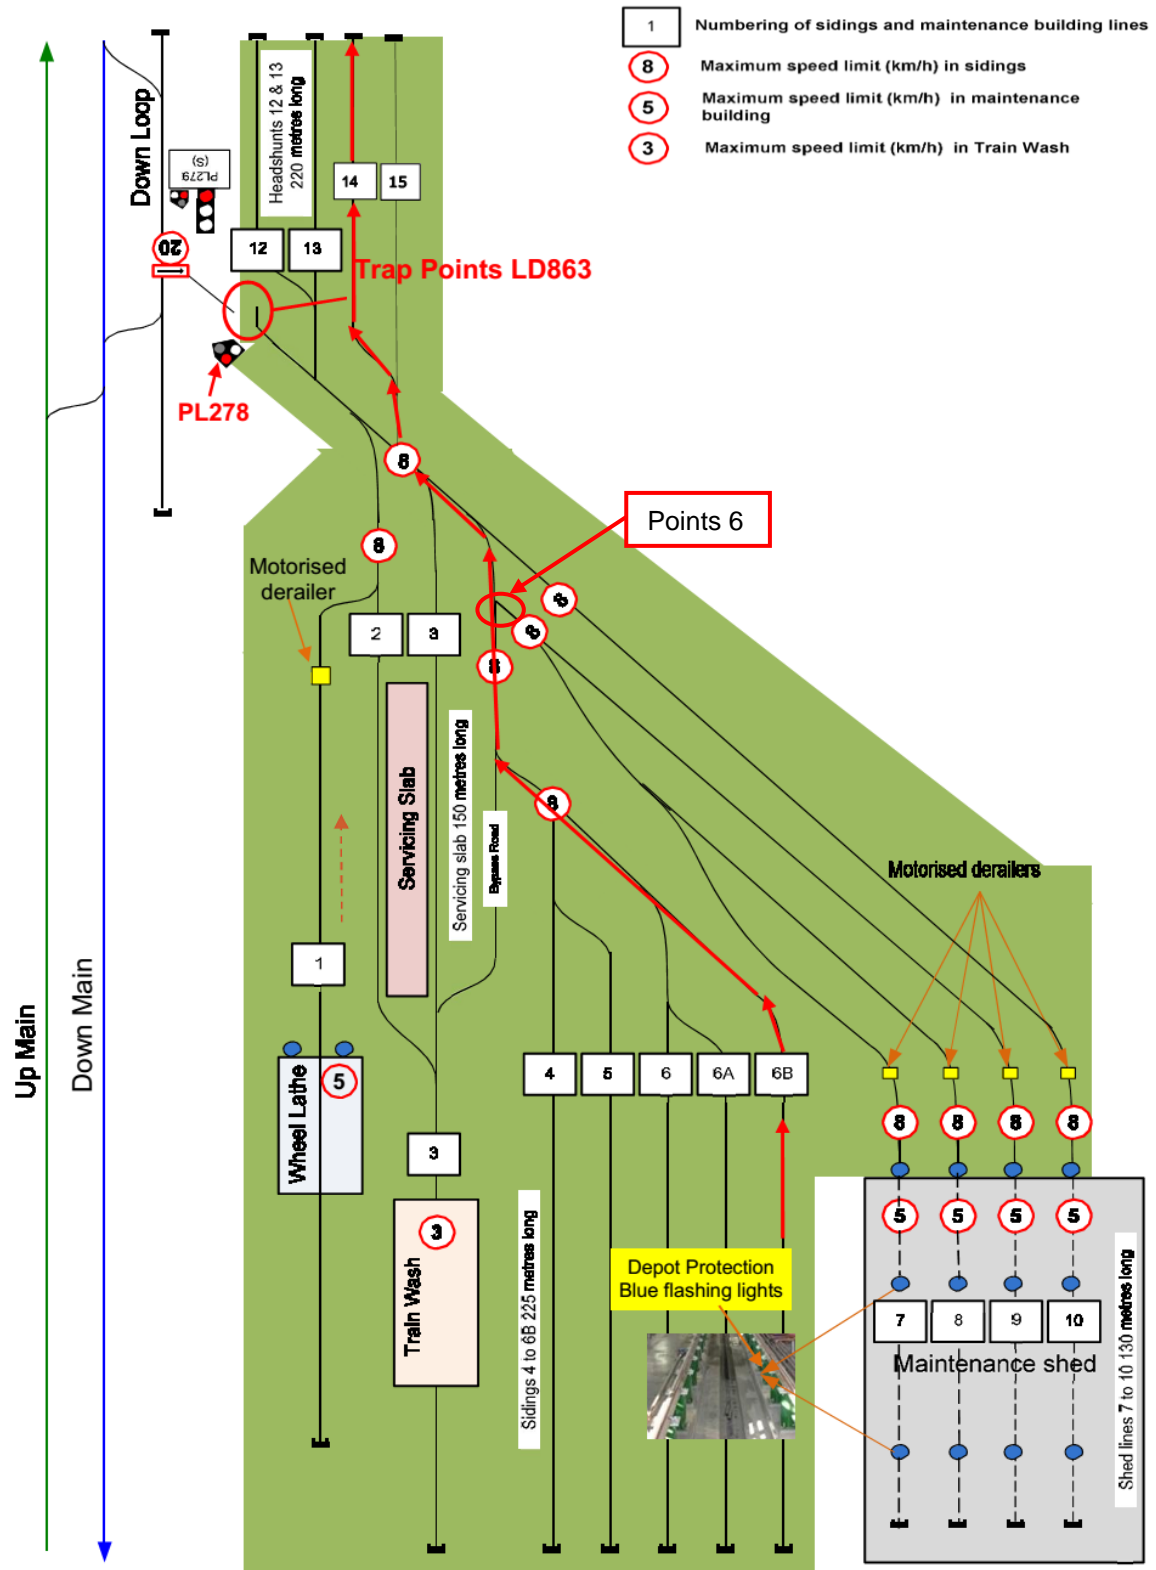
Figure 4 – Simplified illustration of LTCD (not to scale). The route from Road 6B to Road 14 is shown in red.

- 16 The LTCD consists of servicing slabs, a train wash, wheel lathe and a maintenance workshop. Rail lines and sidings facilitate the movement of trains throughout LTCD and are often used of storage of trains, see Figure 4.

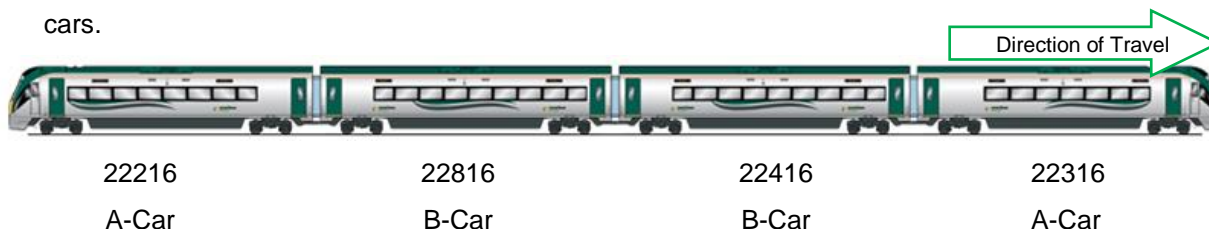
Figure 5 – Illustration of ICR, displaying the configuration on the day of the accident

- 17 The train involved in the accident was an empty 22000 class ICR (Set 16) consisting of four cars, 22216, 22816, 22416 and 22316; car 22316 was leading at the time of the accident (see Figure 5). ICR cars with a driving cab are known as A-cars and the intermediate cars are known as B-cars.

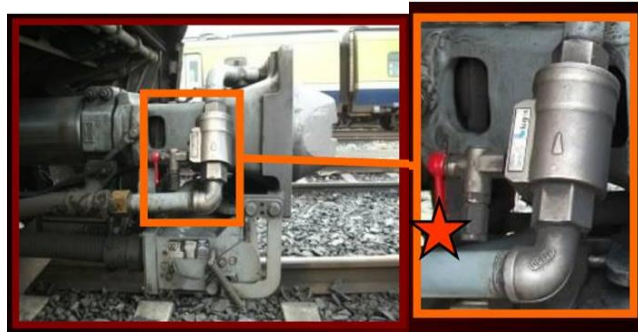
Figure 14 – Brake pipe override air cock handle

- Coupling of assisting ICR to failed ICR – Which requires aligning and coupling to the failed 22000 class; applying the brakes (emergency and parking); confirming coupling integrity; and, turning the brake pipe override air cock handle (marked by red star in Figure 14) through 90° on both couplers;

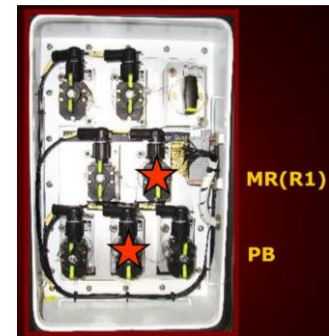
Figure 15 – MR(R1) & PB

- Further preparation of failed ICR – Which requires isolating air cock Main Reservoir (MR)(R1) and Parking Brake (PB) by turning handle (marked by red star in Figure 15) to the horizontal position on all cars of the failed 22000 Class;
- Further preparation of assisting ICR – Which requires isolating air cock MR(R1) by turning handle to the horizontal position on all cars of the assisting 22000 Class;
- Final preparation of failed ICR – Which requires the releasing of the parking brake; mounting of portable tail lights; and conducting a brake continuity test.

61 By carrying out these procedures correctly; when the vehicles are divided, the brakes will apply on all vehicles.
