Railway Accident Investigation Unit

INVESTIGATION REPORT

Vehicle struck by train at Cartron level crossing, XM220, Co. Mayo, 17th August 2018

RAIU Report No: 2019 – R003
Report Published: 03/09/2019

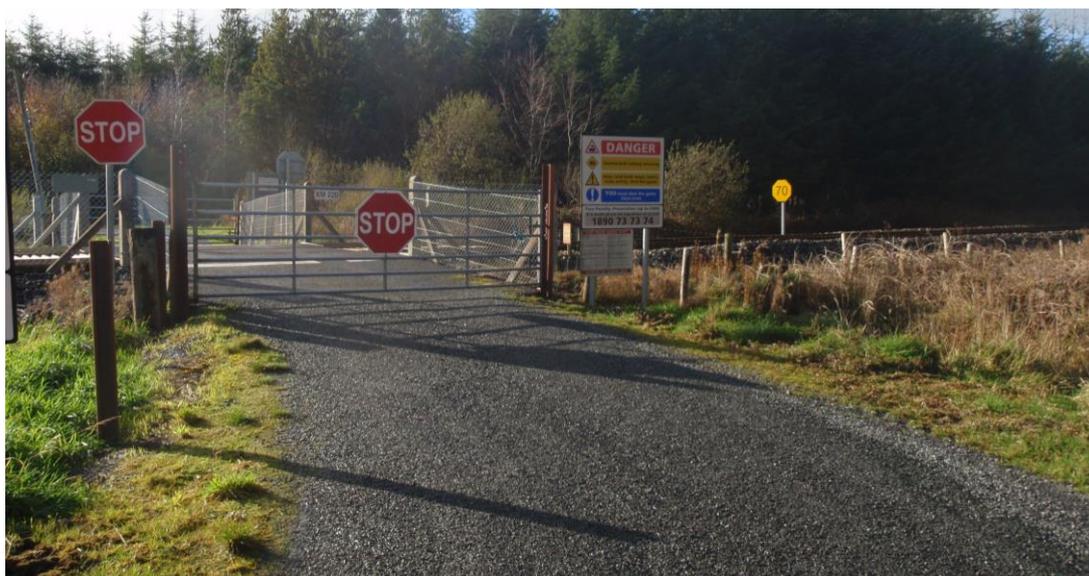
Figure 3 – Cartron Level Crossing, LC XM220

- 6 LC XM220 is situated approximately 2 miles and 373 yards (3.56 kilometres (km)) from Claremorris Station on the Down approach. The road access for LC XM220 is from an unrestricted third class public road, L55381, located off the N60 (Castlebar – Claremorris (County Mayo) adjacent to Lugatemple (County Mayo), to which the public have unrestricted access, see Figure 3. The third-class regional road has a speed limit of 80 kilometres per hour (km/h).

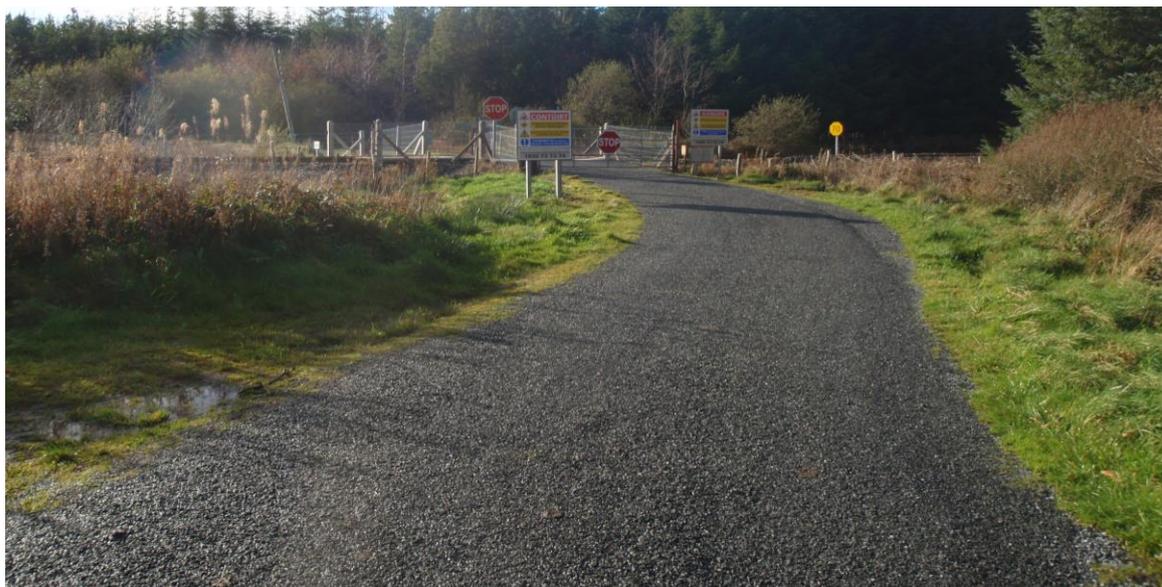
Figure 7 – View from public road L55381 on approach to XM220

40 LC XM220 is located on local road, L55381, which runs from the N60 to Streamstown and through Gortfadda. The road way where it meets the level crossing runs in a southwest direction with the railway line running north west to south east, see Figure 7.

41 The road has a tar and chip surface that was laid recently and has a speed limit of 80 km/h.

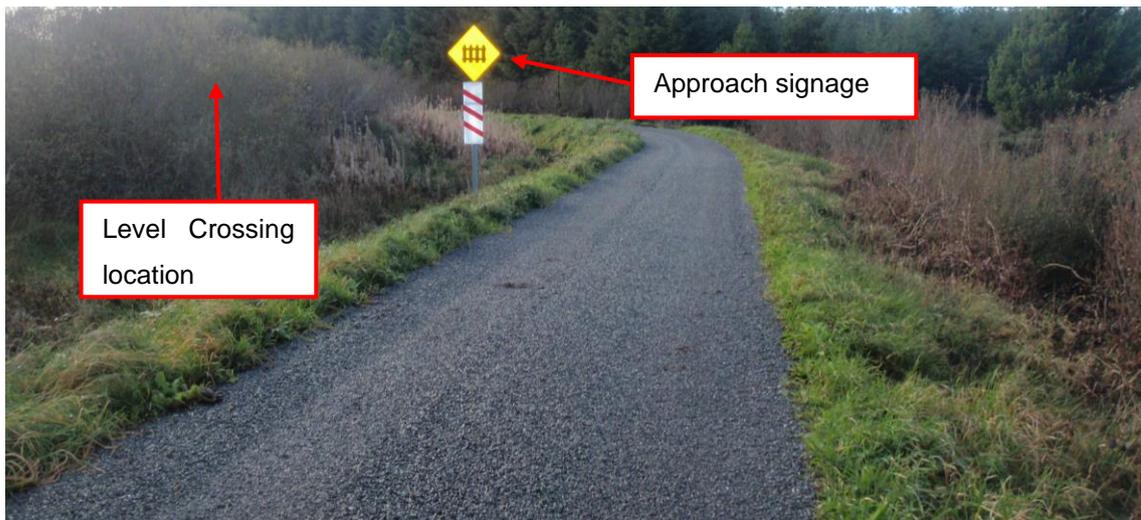
Figure 10 – Access to LC XM220 from L55381

46 The advance warning signage on the approach to LC XM220 is the responsibility of Mayo County Council in line with the Traffic Signs Manual (paragraph 44); and are verified to be in place, annually, by IÉ-IM. There are three advance warning signs on the approach at 100 m intervals, see Figure 10 for one of the signage posts 300 m in advance of LC XM220, where it can be seen there is no illustration of a train (unlike other level crossing signage (paragraph 45)).

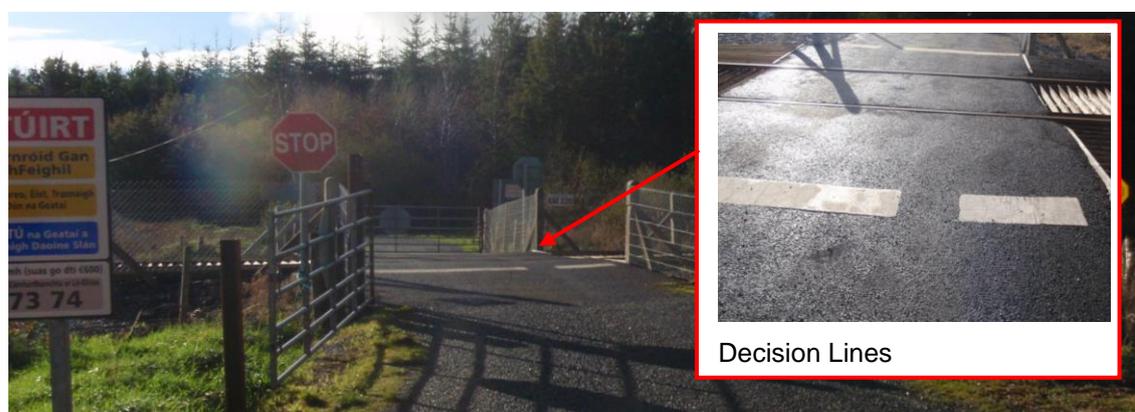
Figure 15 – Approach to XM220 with Decision Line

- 56 This Decision Line is a 300 millimetres (mm) continuous white line which is painted from the left edge to a point, two-thirds across the roadway. and continues as a broken white line to the right edge of the roadway. The line is located approximately 2 m from the running edge on each side of the level crossing road approaches, see Figure 15.

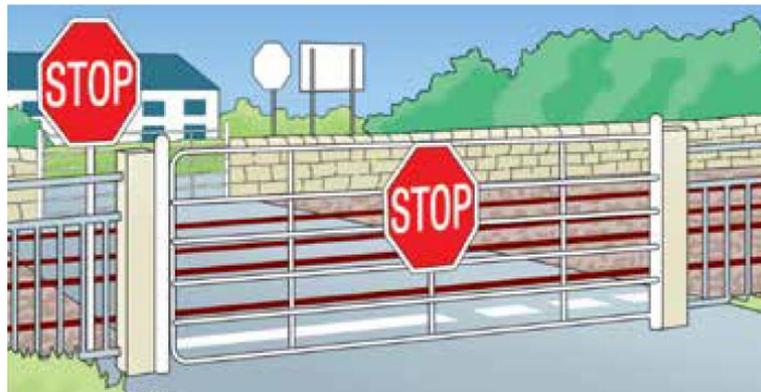
Figure 21 – Unattended Level Crossing Illustration

75 It is noted that the Rules of the Road illustration depicts the Decision Line but does not outline its purpose. No other signage (IÉ-IM signage) is depicted in the illustration.
