**Railway Accident
Investigation Unit
Ireland**

INVESTIGATION REPORT

Trend investigation into Signals Passed At Stop on the LUAS network

RAIU Report No: 2022 – R003

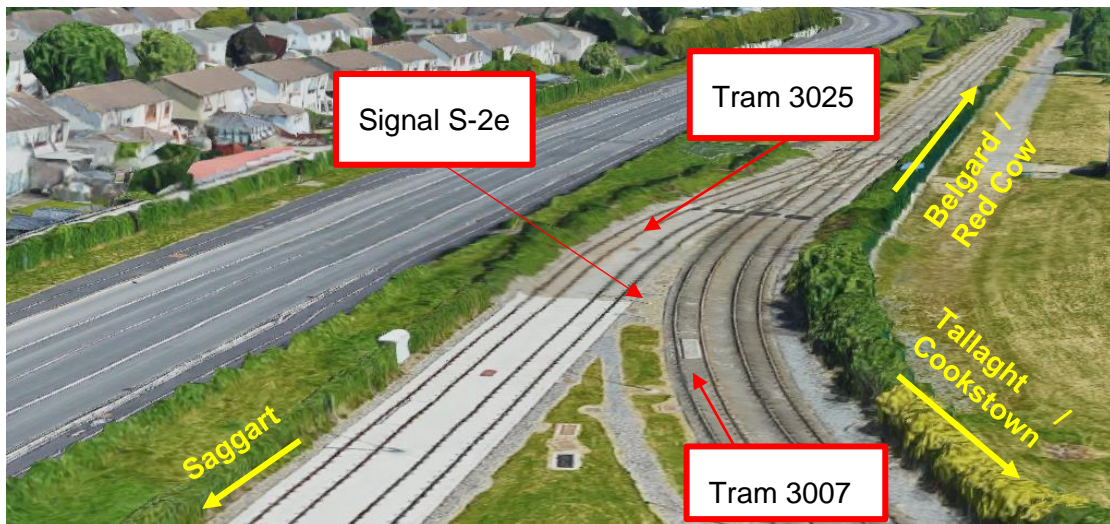
Figure 8 – Signalling at Cookstown LSS

111 At approximately 15:07 hrs, outbound tram to Saggart, Tram 3025, approached Cookstown Interchange (see Figure 8 for location and signal locations).

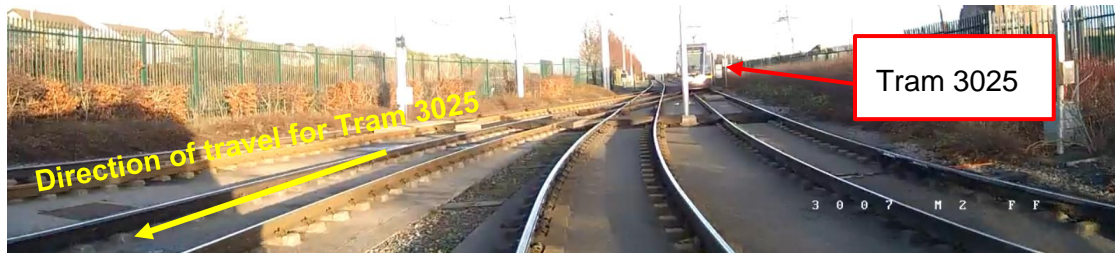
Figure 10 – Tram 3025 approaches the Interchange (image from Tram 3007)

- 113 At the same time, Tram 3025, travelling outbound towards Saggart, entered Cookstown LSS on a “Proceed” aspect, see Figure 10.

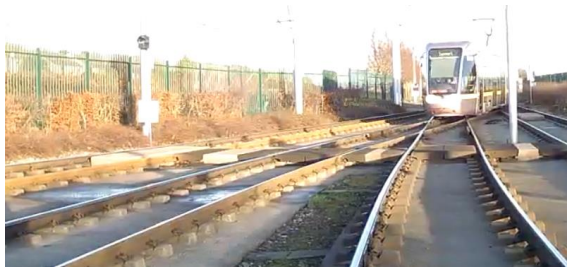
Figure 11 – Tram 3025

- 114 On seeing Tram 3025, Driver 3007 stopped Tram 3007, allowing Tram 3025 to travel over the interchange, see Figure 11 (FFCCTV image from Tram 3007 of Tram 3025). Had Tram 3007 not stopped, it would have collided with Tram 3025, see Figure 11 (FFCCTV image from Tram 3025 of Tram 3007).

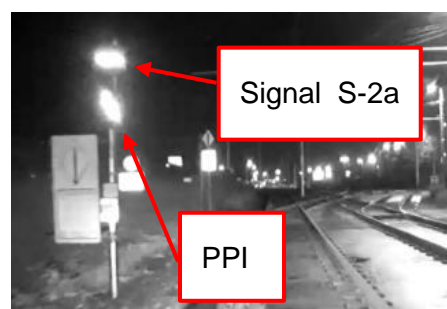
Figure 16 – Signal S-2a at Stop

119 On Tuesday 16th February 2021, Driver 4011 was scheduled to operate the Sweep Tram (Red Cow to Tallaght). At 05:09 hrs, as Driver 4011 approached Cookstown LSS, Signal S-2a, was displaying a Stop aspect see Figure 16. The points were set in the default position for Tallaght as indicated by the PPI, Driver 4011 had inputted the incorrect trip code on the AVLS.

120 Tram 4011 travelled past Signal S-2a at Stop and continued to Tallaght. At Tallaght, Driver 4011 contacted LNMC to report that he may have been involved in a SPAS event.

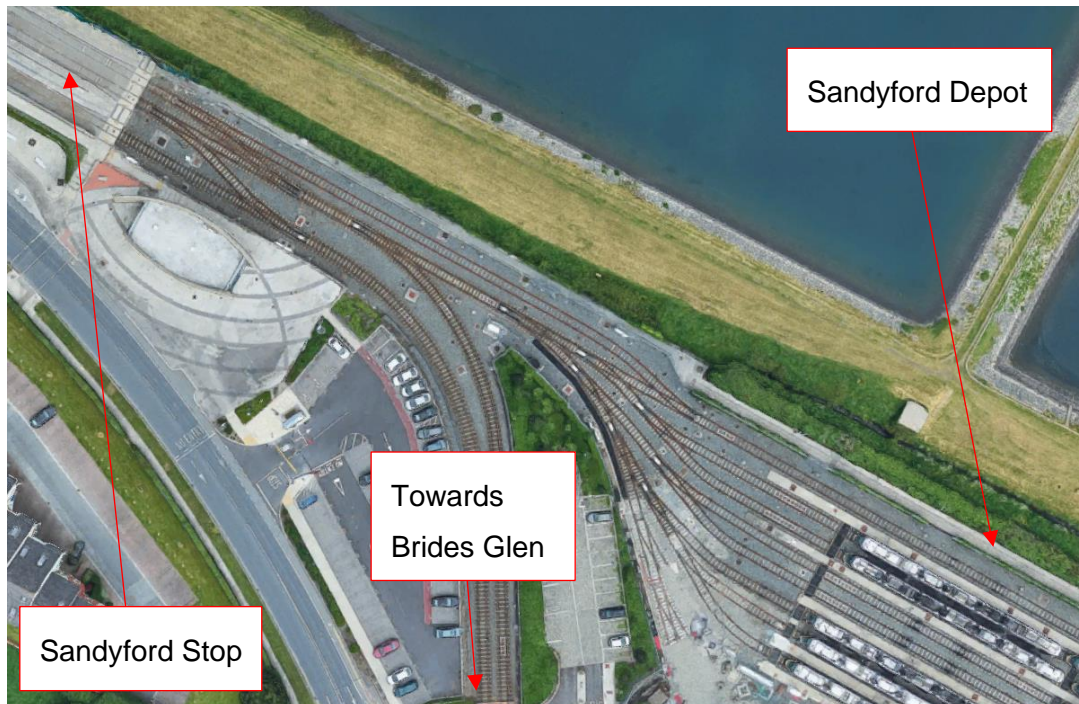
Figure 17 – Sandyford

123 In terms of similar occurrences at these locations prior to 2019 (from 2012-2018), there had been thirteen previous occurrences of SPAS in the Sandyford Stop location.

129 Tram 4012 was stopped at Signal S-2 Southbound (Figure 17)¹⁵; points were set for the depot movement. Driver 4012 did not input an RTS request to for a proceed aspect from Signal S-2. Driver 4012's focus was on the passengers/pedestrians (Figure 20 shows two pedestrians in the area of Signal S-2 at the time of the incident).

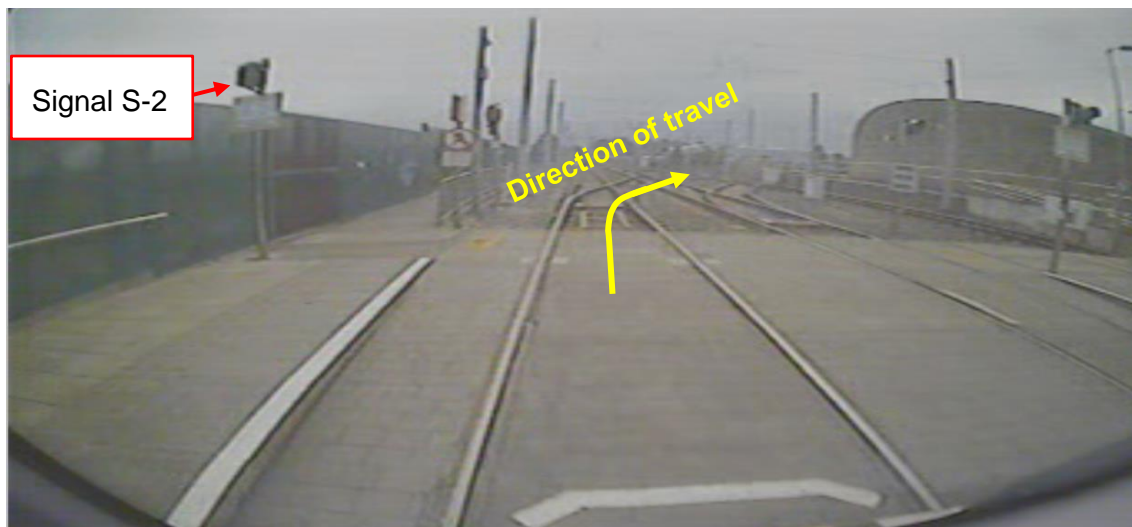
Figure 21 – Stopped position at Sandyford Stop

133 During the operation of the Beechwood to Brides Glen service, southbound, Driver 5006 was stopped at Sandyford Stop at 10:53 hrs (see Figure 21).

134 Driver 5006 checked the points, they were set for his route; he also was checking his mirrors. Driver 5006 did not select input an RTS request for a proceed aspect from Signal S-2 (see Figure 17), and departed Sandyford Stop, passing Signal S-2 at Stop. Driver 5006 thought that he did check Signal S-2 before departing; although, Driver 5006 said there was glare due to the sun and his sunglasses were in the trailing cab.

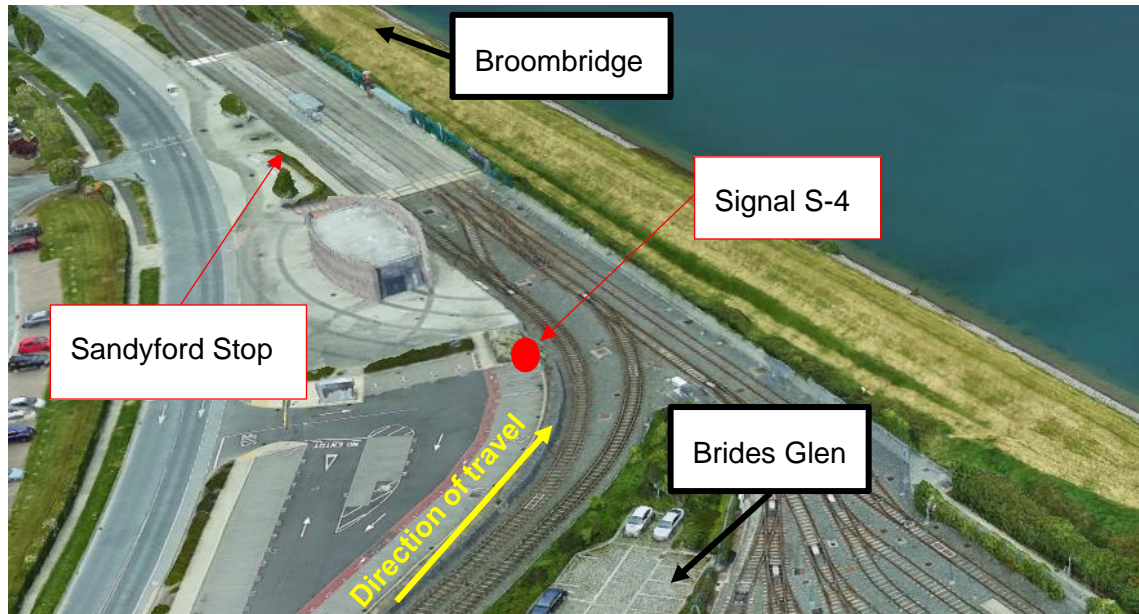
Figure 22 – Signal S-4 Northbound

- 136 On the 26th January 2020, Driver 5031 was operating the Brides Glen to Broombridge passenger service. On approach to Sandyford northbound platform, Signal S-4 (see Figure 22 for location of signal) was displaying a Stop aspect (Figure 23).

- 137 Driver 5031 did not look at the signal and instead looked at the PPI (Figure 23) to see if his route was set for the northbound platform, which it was. Driver 5031 did reduce the speed of the tram, but did not stop, passing the signal at Stop.

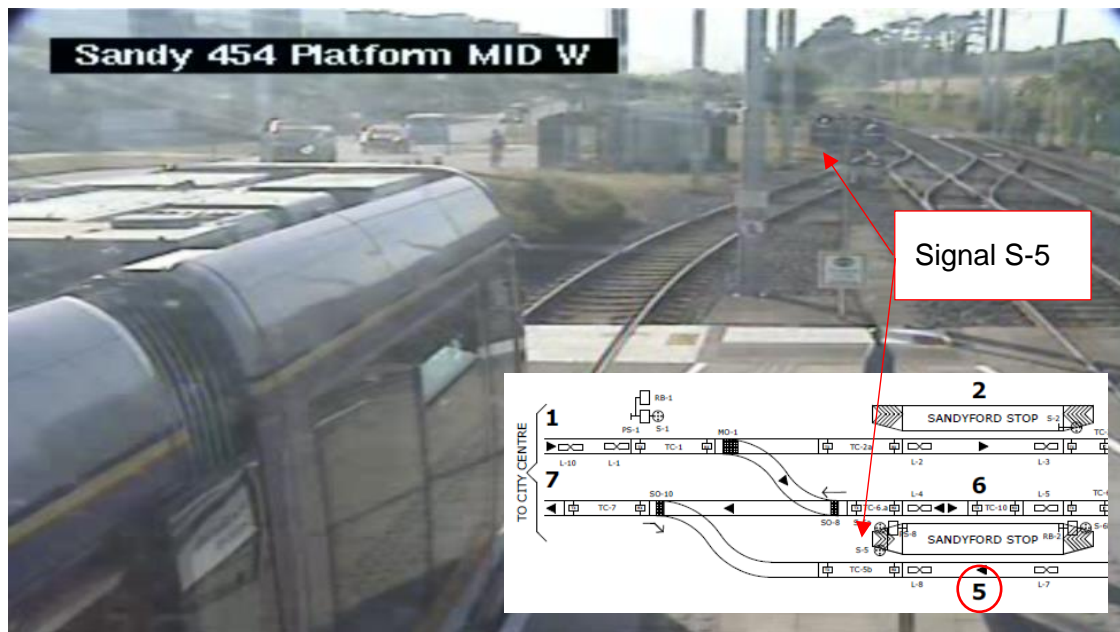
Figure 25 – Signal S-5

- 141 On the 28th May 2020, Driver 5016 was operating the Brides Glen to Broombridge northbound passenger service. Tram 5016 stopped on Sandyford northbound platform to allow passengers to exit and enter the tram.
- 142 While stopped at Sandyford Stop (route 5 in Figure 25), Signal S-5 was displaying a Stop aspect. Driver 5016 did not input an RTS request and proceeded against Signal S-5 at Stop, see Figure 25; Driver 5016 thought he may have pressed the wrong button instead of the RTS request button.

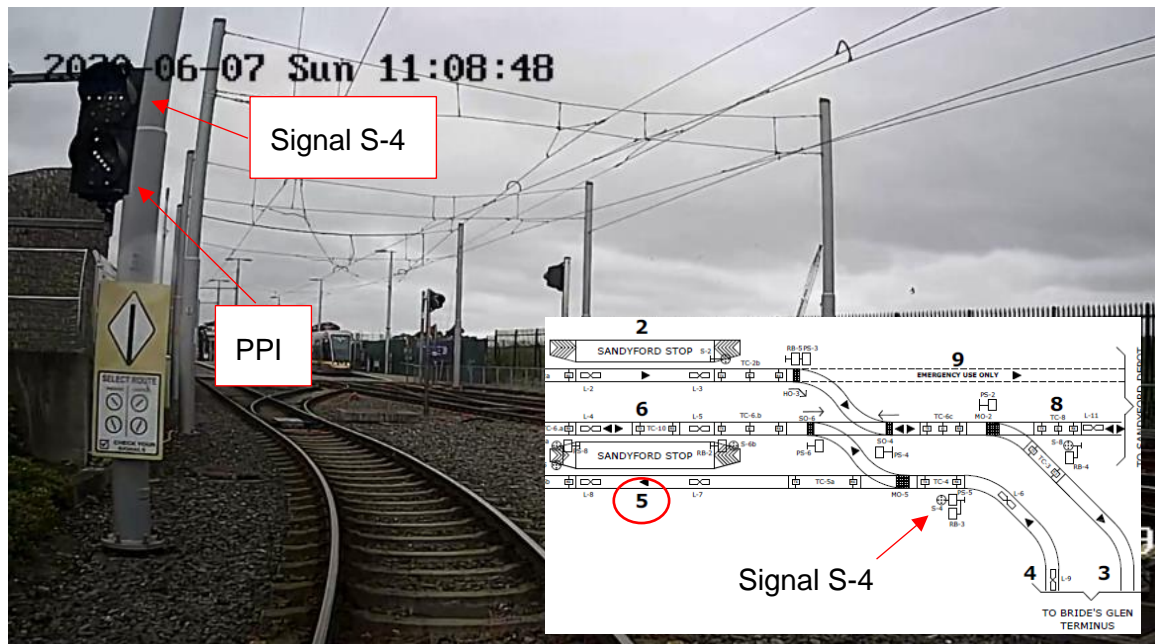
Figure 26 – Signal S-4 and Sandyford layout

144 On the 7th June 2020, Driver 5029 was operating the Brides Glen to Sandyford northbound passenger service. On approach to the northbound platform (Route 5 in inset of Figure 26), Signal S-4 was displaying a Stop aspect (see Figure 26); this was due to the AVLS not being set correctly, meaning that Signal S-4 did not give an automatic proceed on the approach of Tram 5029, as a result Driver 5029 was required to input make an RTS request.

145 Driver 5029 did stop but saw that the PPI was set correctly and proceeded past Signal S-4 at Stop.

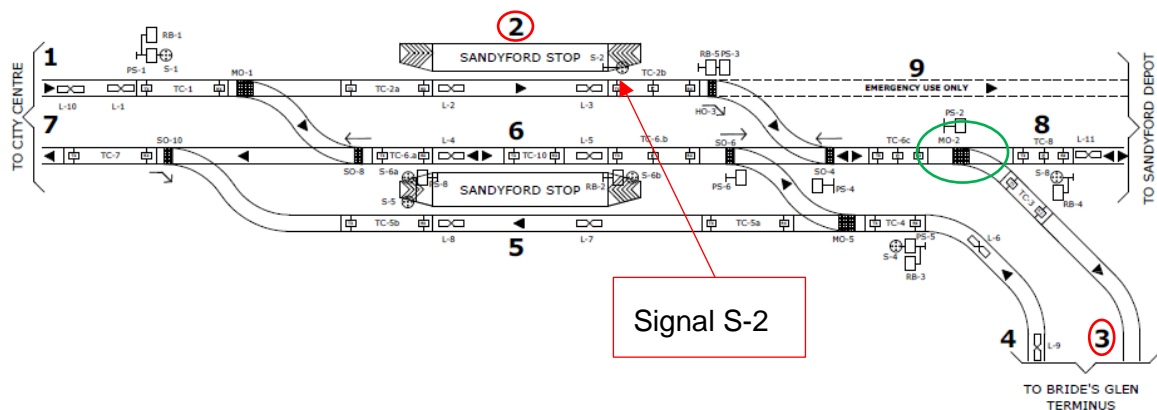
Figure 29 – Sandyford layout, see Signal S-2, and Routes No. 2 and No.3 circled

152 At 19:45 hrs, Driver 5017 inputted the RTS command at the control loop at tram signal S-2 (see Figure 29) to request the tram proceed signal aspect and correct route setting for destination, Brides Glen (Route No.2 to No.3, see Figure 29); however, as another tram was still occupying the track circuit (Route No. 8), the Sandyford LSS system disregarded Driver 5017's RTS command and the proceed signal aspect was not given.

153 Driver 5017 did not realise that the proceed aspect was not displaying of Signal S-2 and proceeded past Signal S-2 displaying a Stop aspect.

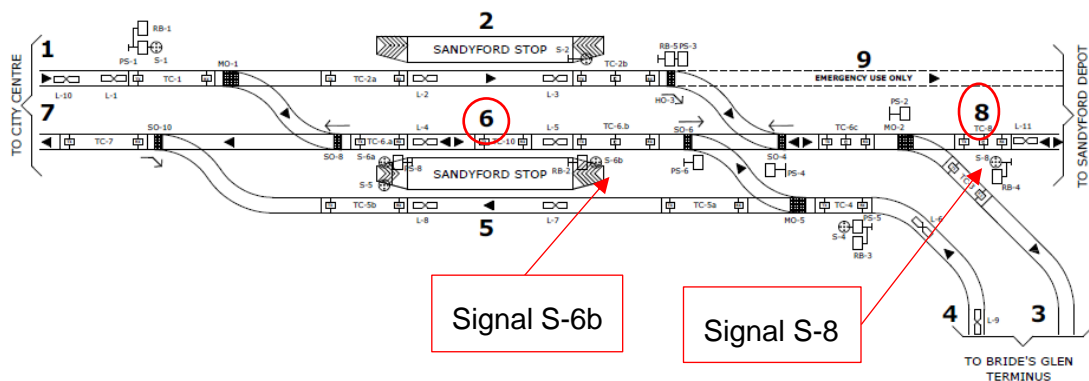
Figure 32 – Sandyford layout

168 On the 12th March 2020, Driver 4014¹⁸ was rostered to do a preparation of Tram 4014 and take it into service (Sandyford to Broombridge), departing from Sandyford Central Platform. Tram 4014 was required to travel past Signal S-8 to arrive at the Central Platform, see Figure 32 (travelling from 8 to 6 (circled)). During preparation, Driver 4014 noticed that the battery was flat for the hand-held radio, which required replacement, this made Driver 4014 feel under pressure as he thought he was going to be late entering service.

- 171 Driver 4014 continued onto the Central Platform, where he saw “Stop – Single Dot” aspects and contacted LNMC who suspected a SPAS had occurred and requested that Driver 4014 return Tram 4014 to the depot.
- 172 At 06:40 hrs, Driver 4014 was now required to input an RTS command for Signal S-6b (see Figure 32), to re-enter the depot, however he did not and proceeded past Signal S-6b at Stop, see Figure 34.

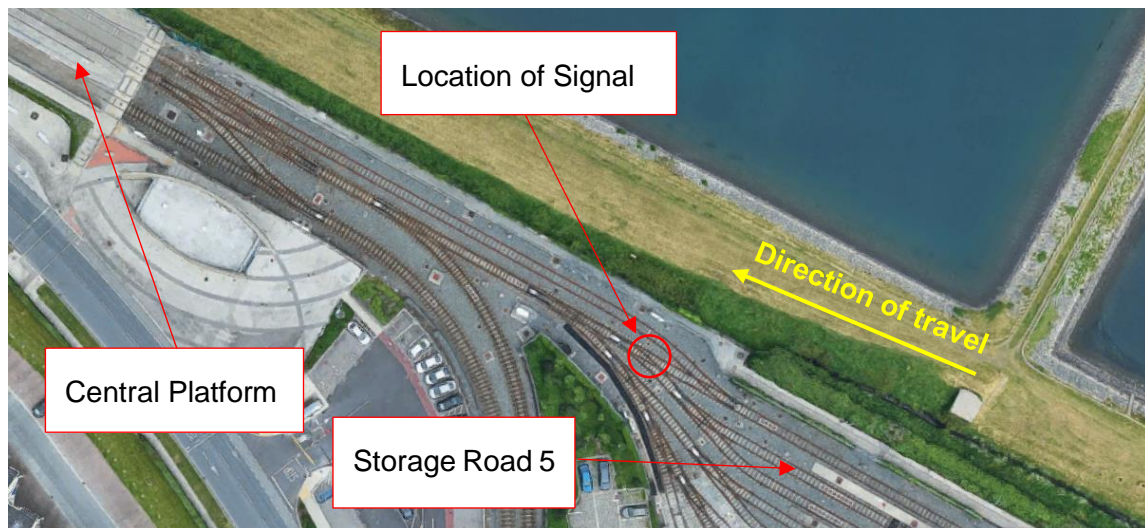
Figure 35 – Locations relevant to the incident

174 On the 7th October 2020, Driver 5014 was required to prepare Tram 5014, located on Storage Road 5 Sandyford Depot, for service. Driver 5014 was given permission, by LNMCC, to move Tram 5014 from Storage Road 5 to the Depot Gates (see Figure 35).

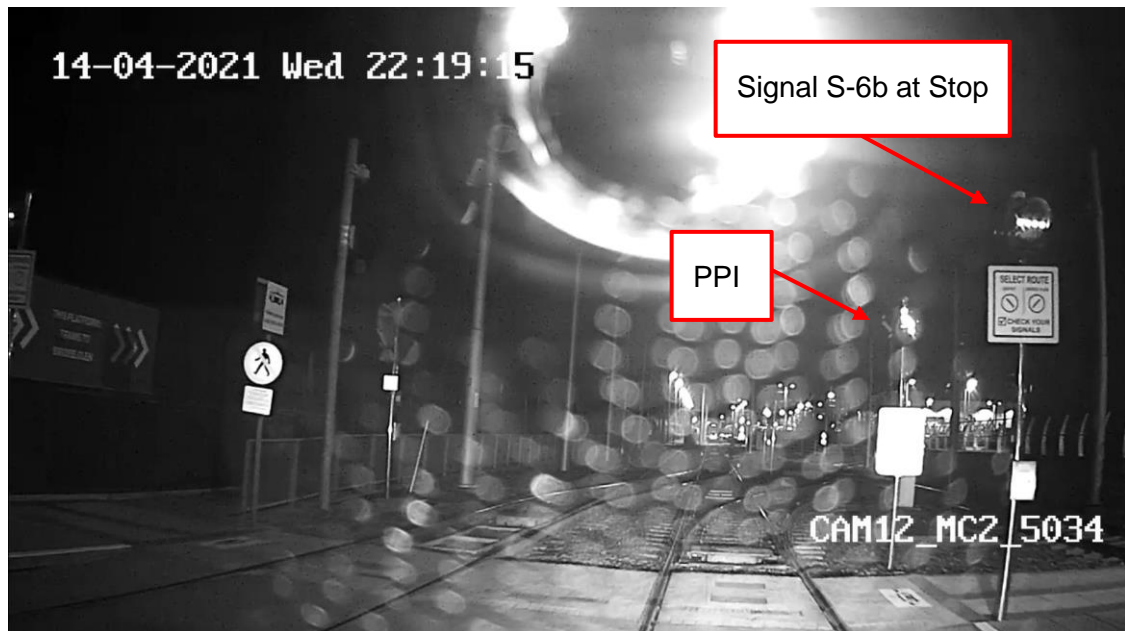
Figure 38 – Tram 5034 at Sandyford Central Platform

- 183 On the night of the incident, Driver 5034 was scheduled to work at Sandyford Depot (the shift involves any operational requirements including tram depot movements).
- 184 At approximately 22:00 hrs, LNMCC requested that Driver 5034 move Tram 5034 from Storage Road No. 1 to Sandyford Central Platform and back into the Depot onto North Apron No. 3.
- 185 Driver 5034 proceeded to Sandyford Central Platform without issue. At Signal S-6b, Driver 5034 was granted permission to re-enter the depot. Driver 5034 did input the RTS but did not request the left route; but observed the correct route was set for the movement (left direction on the PPI), see Figure 38.
- 186 Driver 5034 did not check the aspect of Signal S-6b and travelled past Signal S-6b at Stop.

- 187 On the day on the incident, Driver 5034 was distracted by his upcoming retirement (8 days after the incident). It appears that Driver 5034 was reliant on the PPI, set for his route, rather than the signal.

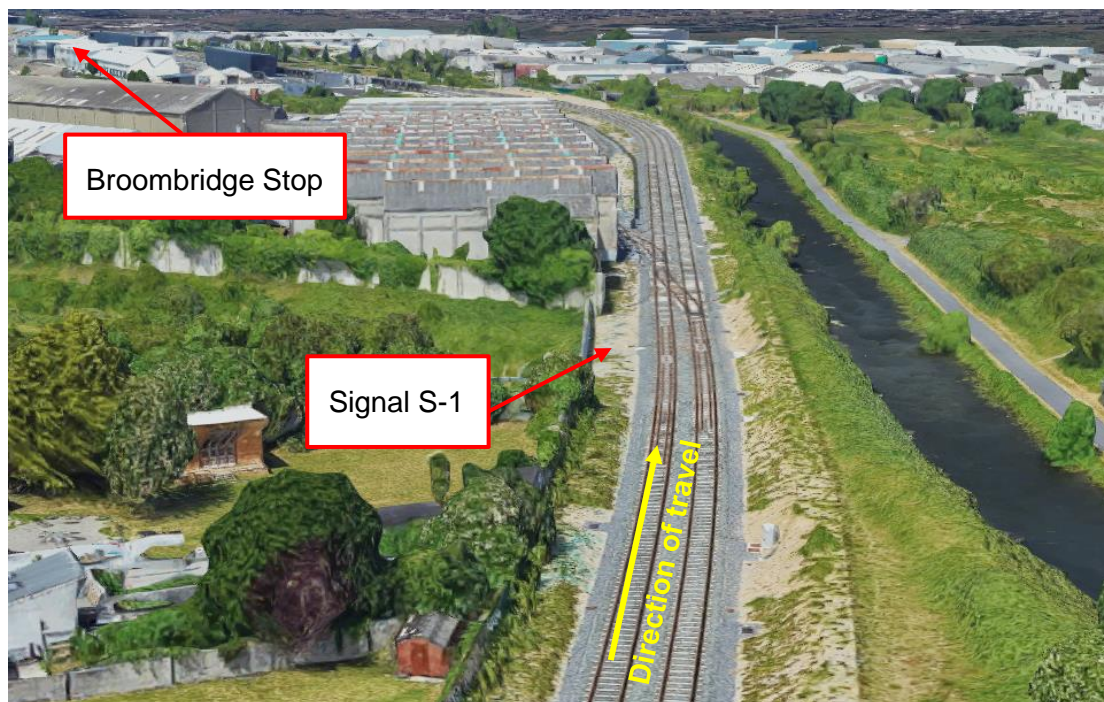
Figure 39 – Location of the incident

195 As Driver 5001 travelled towards Signal S-1 on the approach Broombridge (see Figure 39) at approximately 18:22 hrs, he was hoping not to run into issues like the other drivers which would delay his meal break.

196 As a result, Driver 5001 was looking at the PPI at Broombridge Depot (see inset Figure 40) and was not looking at Signal S-1 and passed it displaying a “Stop” aspect; he had an incorrect expectation that Signal S-1 would be displaying a “Proceed” as he normally received a proceed at this signal. Driver 5001 normally approaches Signal S-1 on a “Proceed” aspect. Driver 5001 was unaware that he passed Signal S-1 at Stop, therefore, continued onto Broombridge Stop.

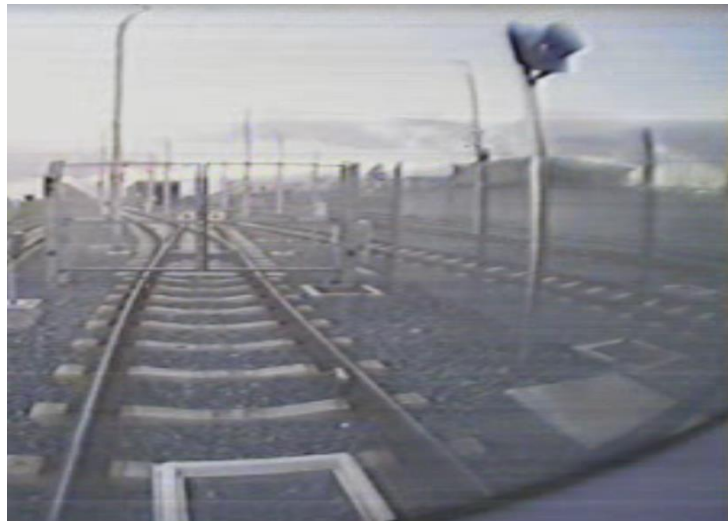
Figure 41 – PPI displaying a “Stop – Single Dot” aspect

197 On Thursday 21st February, the last tram movement over Points MO 37 was Tram 5005 at 17:41 hrs (an hour before the accident). The driver of Tram 5005 reported to LNMCC that the PPI were displaying a “Stop – Single Dot” aspect, Figure 41. No actions were taken; the radio communication was not recording; and, there was no TED report for the fault.

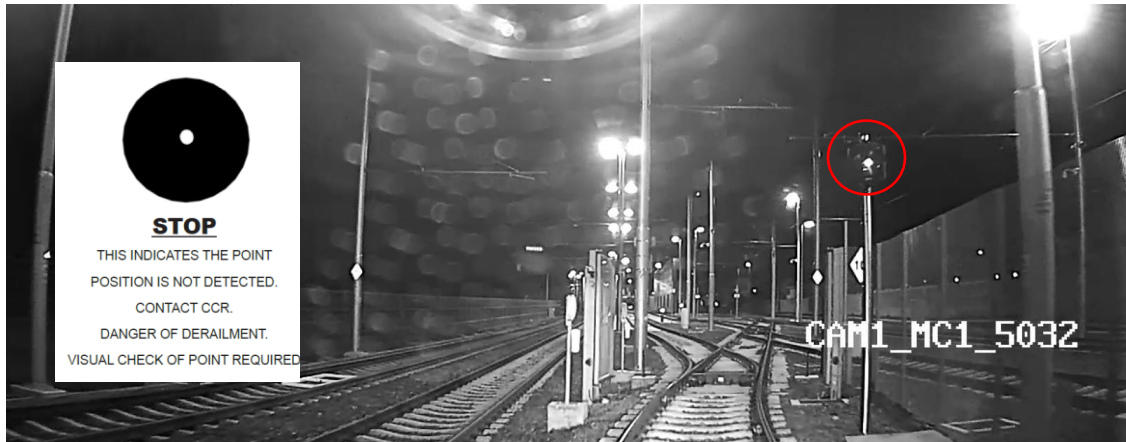
Figure 43 – PPI displaying a “Stop – Single Dot” aspect (circled red)

200 Tram 5032 then approaches the PPI (the TSI Manual states that this is the Stopping Point for drivers). The PPI is displaying a “Stop – Single Dot” aspect, see Figure 43; this aspect indicates “the point position is not detected. Contact CCR. Danger of Derailment. Visual Check of Point Required”, see inset Figure 43. Points MO 37 were not set for the movement.

201 At the time, Driver 5032 was looking down onto the driver’s duty sheet and did not see and stop at the PPI; instead Tram 5032 continued onto Points MO 37, which resulted in the leading M1 bogie becoming derailed.

202 Driver 5032 applied the normal brake and then the emergency brake and the tram came to a stop in the derailed position.

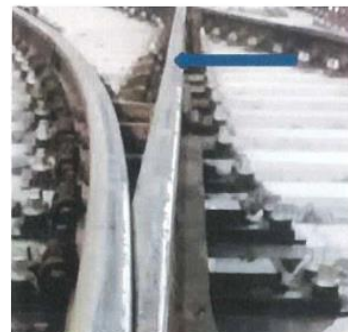
Figure 44 – Points MO 37

203 A post-accident inspection of Points MO 37 found no faults with the points i.e. the track gauge at the switch tip was 1445 mm (maximum tolerance allowed is 1445 mm); and, the cross level throughout the unit was 10 mm (maximum tolerance allowed in 12 mm). However, the inspection found that the last gauge stop bolt on the left-hand switch blade had a gap of 18 mm when in the closed position, see Figure 44.

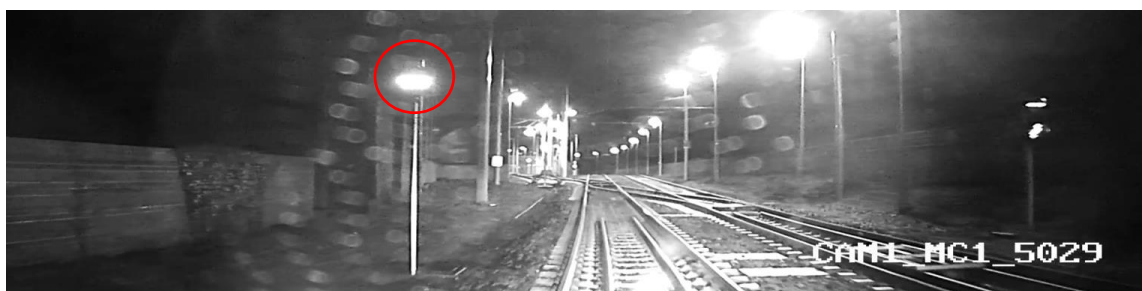
Figure 46 – Tram 5029 approaching Signal S-1 (circled red) at “Stop”

207 As Driver 5029 approached Signal S-1 at Broombridge East Gate, he slowed the tram to approximately 15 km/h (the permitted speed is 20 km/h). Signal S-1 was displaying a “Stop” aspect, see Figure 46. Tram 5029 continues to travel past Signal S-1 at “Stop”.

208 Driver 5029 continued to Broombridge Stop, without realising he had passed Signal S-1 at “Stop”. LNMU saw that a SPAS had occurred on the LSS and contacted the driver.

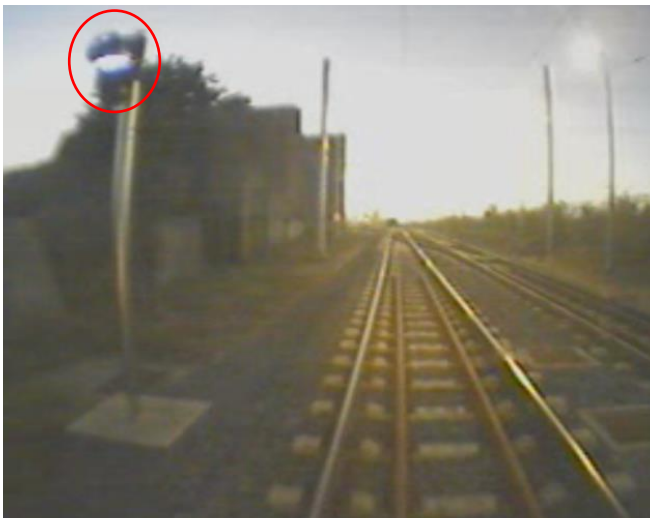
Figure 47 – Signal S-1 a Stop aspect

210 At 20:32 hrs, on route to Broombridge terminus, Tram 5023 approached and passed Signal S-1 at Broombridge East Gate displaying a “Stop” aspect, see Figure 47. It should be noted that Driver 5023’s mobile phone vibrated (mobile phone should have been off, paragraph 44) around the same time as Driver 5023 approached Signal S-1, which may have been a distraction to the driver.

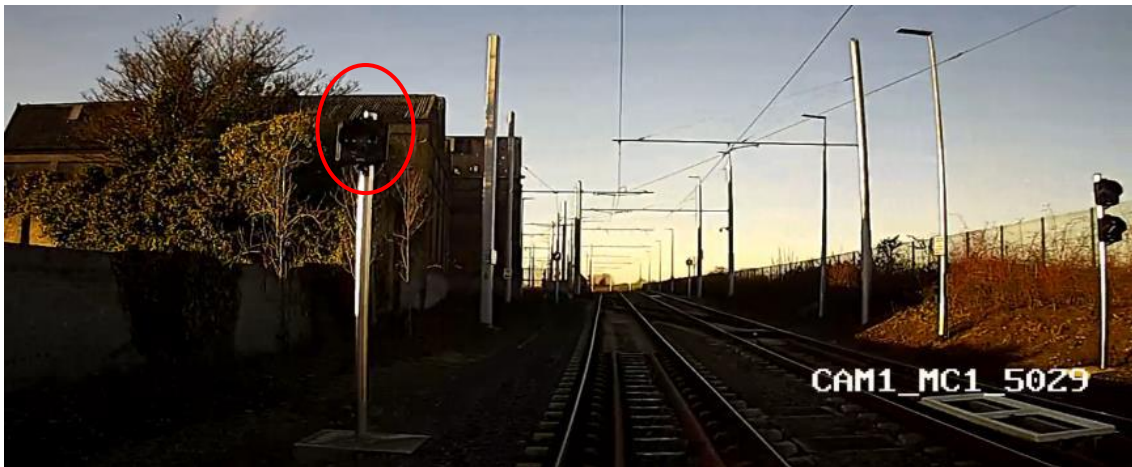
Figure 49 – Signal S-1 displaying a Stop aspect

214 At 15:01 hrs, on approach to Signal S-1 Broombridge, Tram 5029 was travelling at 27 km/h (7 km/h over the authorised speed). Signal S-1 was displaying a Stop aspect, see Figure 49. The sun was in Driver 5029's eyes, however, he was wearing prescription sunglasses. Driver 5029 considers he had a lapse of concentration on approach to Signal S-1.

215 On seeing the Stop aspect, Driver 5029 applied the emergency brake; Tram 5029 came to a stop past the signal. Driver 5029 contact LNMC to report the emergency brake application and possible SPAS.

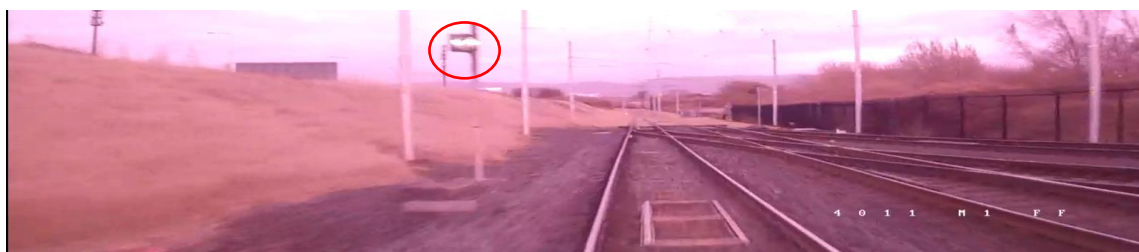
Figure 52 – Signal A08b displaying a Stop aspect

221 Shortly after Tram 4011 approached Signal A08a (Figure 51) displaying a Stop aspect, see Figure 52. Driver 4011 saw the Stop aspect and applied the normal service brake; however, Tram 4011 passed Signal A08a at Stop. Driver 4011 had momentarily forgotten there was a second signal, after Signal A08b.

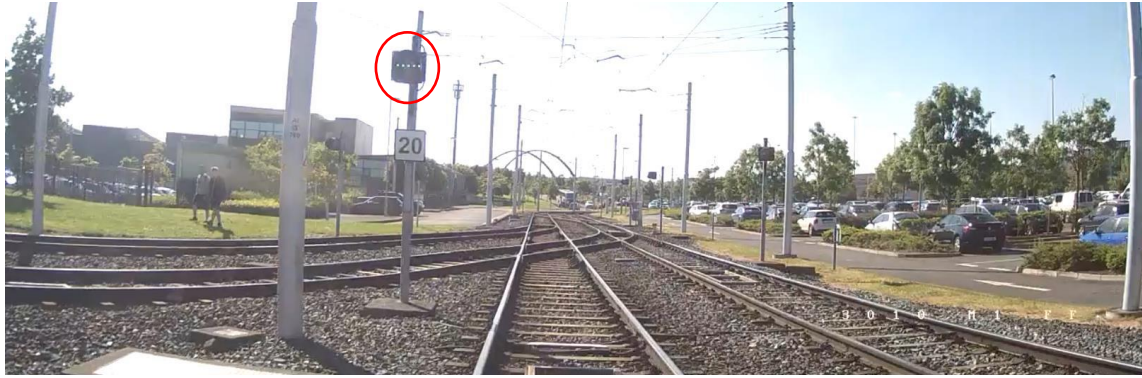
Figure 54 – Signal A08b displaying a Stop aspect (red circled) at Red Cow Delta

225 On approach to the second signal, Signal A08b, this was displaying a Stop aspect. Driver 3010 looked to his left, into the Red Cow Depot, to see the outbound trams terminating. Driver 3010 was not looking for Signal A08b. When Driver 3010 looked forward, he saw Signal A08b was displaying a Stop aspect and applied the normal brakes and not the emergency brakes as he thought he would stop in time.

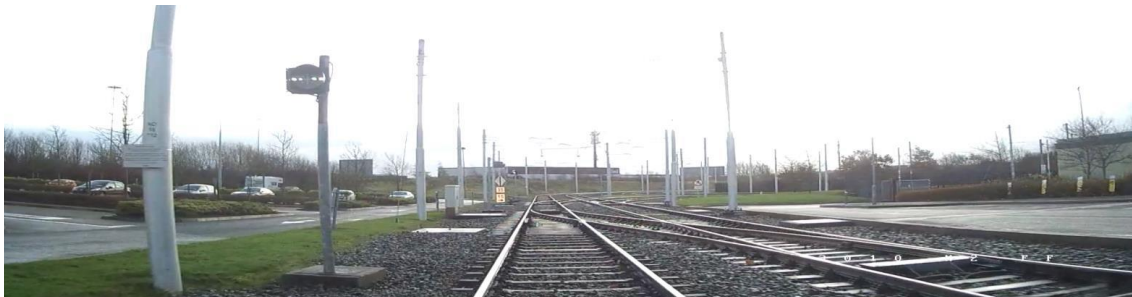
Figure 55 – Signal A08b displaying a “Stop” aspect

229 At 08:45:39 hrs Tram 3010 approached Signal A08b (see Figure 51 for location), Signal A08b was displaying a “Stop” aspect, see Figure 55. Driver 3010 had an incorrect expectation that Signal A08b would upgrade to a “Proceed” aspect.

230 Driver 3010 saw the “Stop” aspect and applied the emergency brake but passed Signal A08b at “Stop”. When Tram 3010 came to a stop, Driver 3010 notified the LNMC.

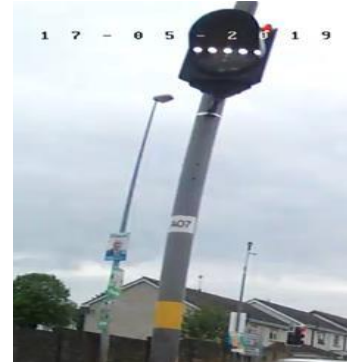
Figure 60 – Stop

236 At 21:23:22 hrs (seventy-seven seconds after arriving at the Stop; thirty-three seconds after the upgrade) Signal A07 downgraded to a Stop aspect (to allow movement of road traffic), see Figure 60, this means Driver 3023 now has to input an RTS request to get a proceed.

237 Driver 3023 did not input the RTS request and proceeded against Signal A07 at Stop at 21:23:23 hrs (one second after the downgrade). Tram 3023 proceeded through the junction with no conflicts with road traffic (see Figure 61). Driver 3023 noted that a car to the driver's left sounded a horn but was not in the junction.

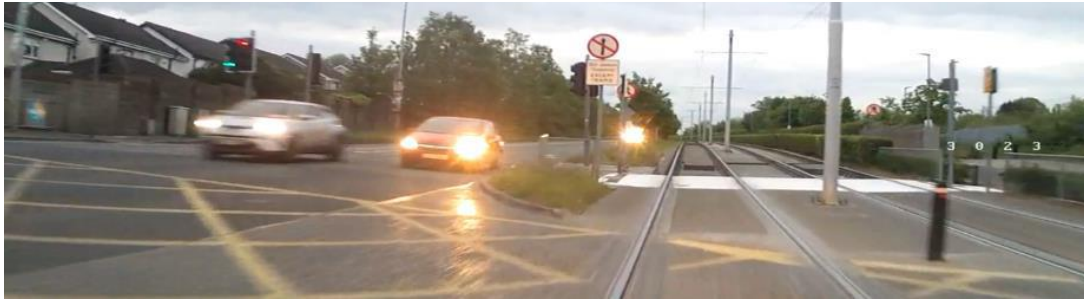
Figure 61 – Tram 3023 travelling through Junction A07

238 Driver 3023 did not realise he was involved in a SPAS incident and finished his rostered duty, it was notified to LNMC by a member of the public.

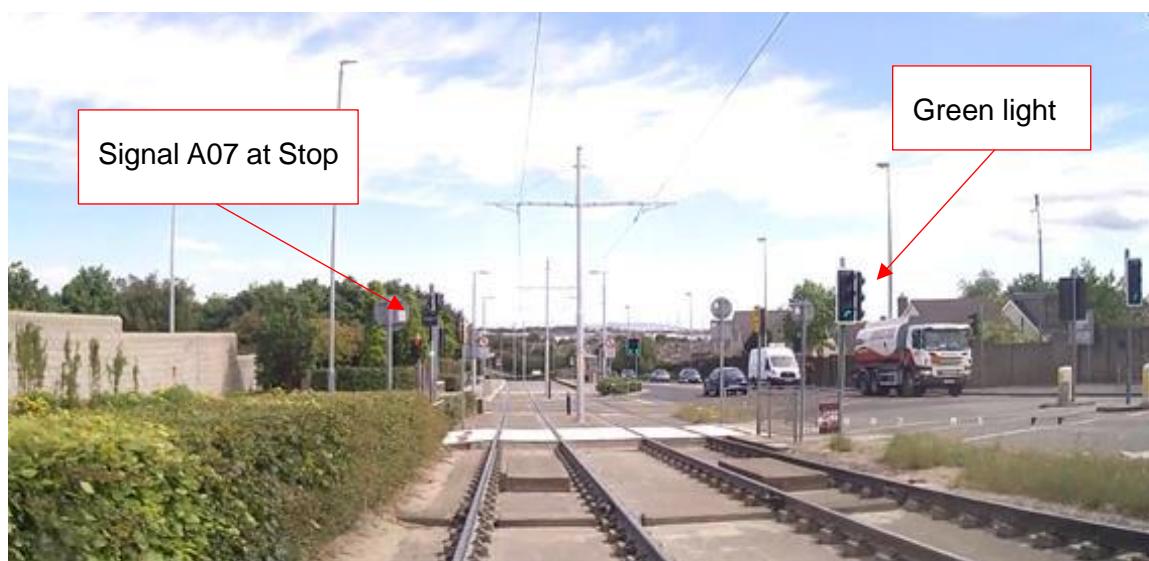
Figure 62 – Signal A07 at Stop

239 On the 21st May 2020, Driver 4007 was operating the Tallaght to Red Cow Inbound passenger service. At 12:08 hrs, Driver 4007 departed Belgard on route to Kingswood, when he approached Signal A07 Inbound displaying a Stop aspect, see Figure 62.

240 Driver 4007 was looking at the road traffic signal on his right which was displaying a green light (Figure 62) and not looking at the tram signal on his approach. When Driver 4007 did look at the signal, it was displaying a Stop. Driver 4007 applied the emergency brakes, and stopped the tram, past the signal, but did not breach the road junction. Driver 4007 reported the incident to LNMC.

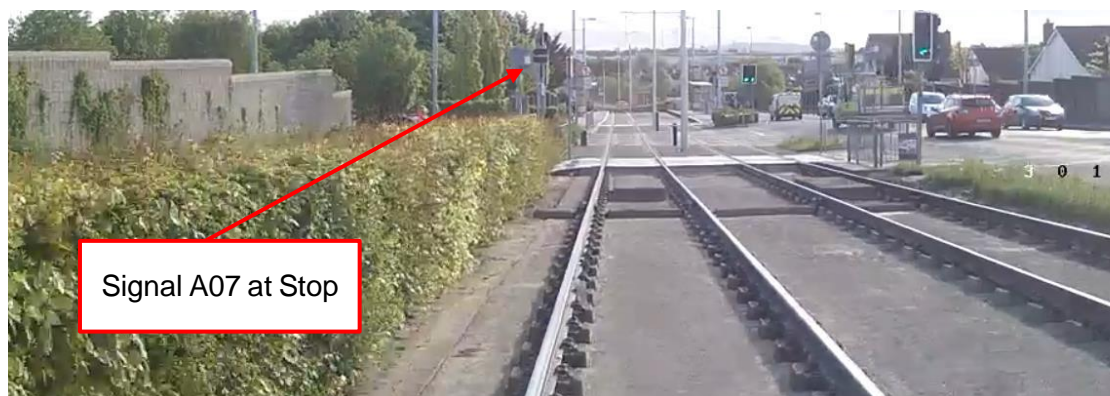
Figure 63 – Signal A07 at Junction A07 (Sylvan Drive / Embankment Road)

241 On the 12th May 2021, Driver 3012 was operating the Saggart to Red Cow passenger service. At 08:23 hrs, Driver 3012 departed Belgard on route to Kingswood; as Driver 3012 approached Signal A07, below the permissible speed limit, the signal was displaying a Stop aspect, see Figure 63.

243 On seeing the Stop aspect, Driver 3012 applied the brakes (normal service brake), however, he did not apply sufficient braking to prevent the tram passing Signal A07 at Stop and despite seeing that the tram was going to SPAS, Driver 3012 did not apply the emergency brake, and passed the signal, stopping on the, but did not enter the road junction (Junction A07).

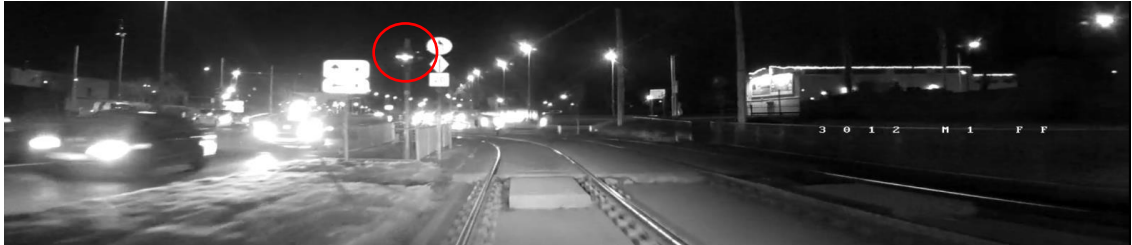
Figure 67 – Signal A05 displaying a Stop aspect (circled red)

247 Signal A05 then downgraded to Stop aspect, see Figure 67. Driver 3012, saw Signal A05 change to Stop but appears to have had an incorrect expectation that the signal would upgrade. On realising the signal would not upgrade he applied the maximum service brake, thinking that this would stop the tram in front of the signal (he did not apply the emergency brake as he thought it may injure passengers).

248 However, Tram 3012 travelled past Signal A05 at Stop, and stopped before the uncontrolled pedestrian crossing. Driver 3012 contacted LNMC to report the SPAS.

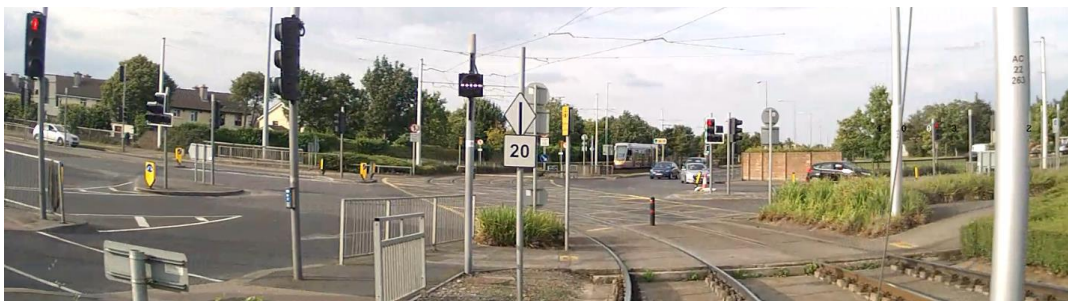
Figure 68 – Signal A05 at Stop

249 On the 15th July 2019, Driver 4003 was operating the Saggart to Red Cow passenger service. As Tram 4003 travelling inbound, approached Junction A05, see Figure 65. Signal A05²² was displaying a Stop aspect, see Figure 68.

250 Tram 4003 continued towards Junction A05. When Driver 4003 saw a car driving over the Main Belgard Road (Driver 4003 thought the car had breached the lights), he applied the brake (Driver 4003 is unsure if he applied the emergency brake or the maximum service brake – the OTDR was not downloaded (OTDR previously discussed in paragraphs 55 - 59). Tram 4003 came to a stop, ahead of the junction and contacted LNMC. Driver 4003 requested a wrong directional movement back to Signal A05, which was granted by LNMC.

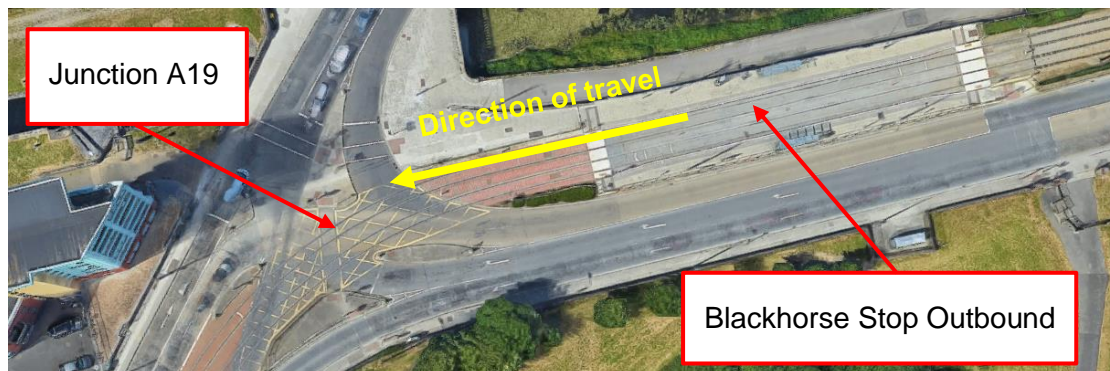
Figure 69 – Blackhorse Stop

252 On the 4th October 2019, Driver 4013 was operating the Point to Red Cow passenger service. At 10:38 hrs, Driver 4013 arrived at the Blackhorse Stop (Figure 69).

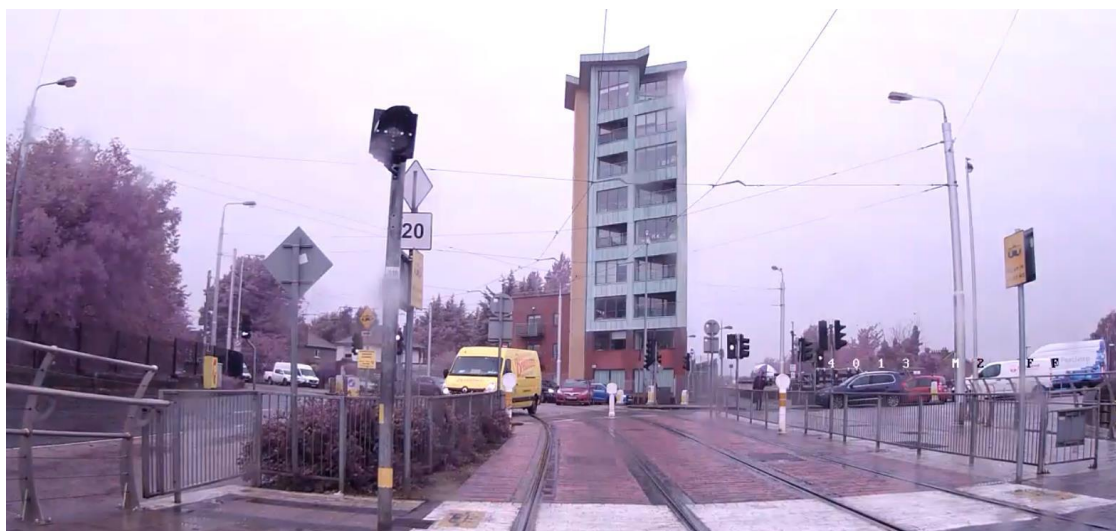
Figure 70 – Signal A19 at Stop

253 When Driver 4013 was ready to depart the platform, he inputted his RTS command to request the tram proceed signal, from Signal A19; however, Signal A19²⁴ remained at Stop (there were issues with some other signals near the location of Signal A19), see Figure 70. Driver 4013 reported the issue to LNMCC. LNMCC informed Driver 4013 that they would contact Dublin City Council to input the signal and to await further instructions.

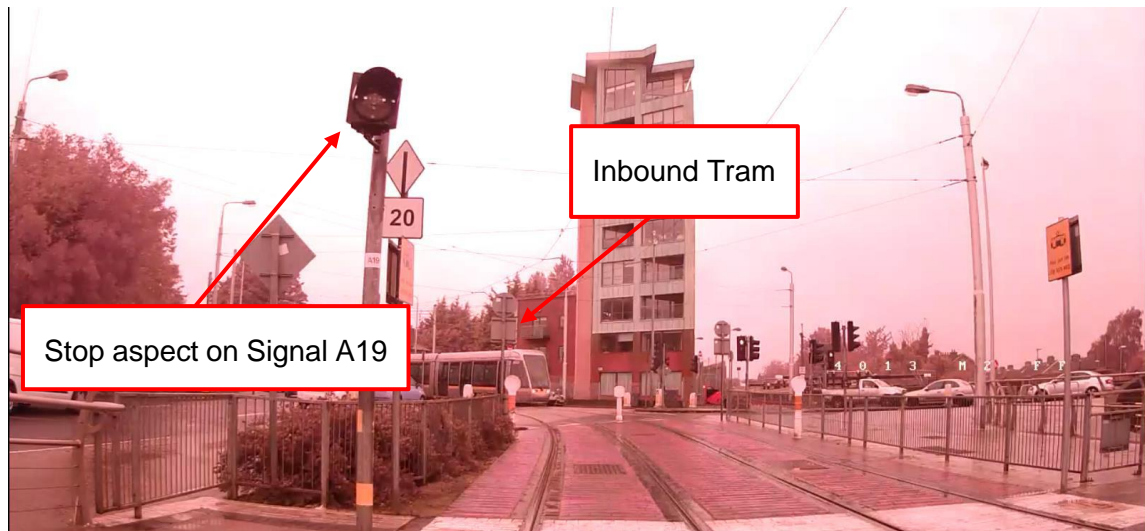
Figure 71 – Inbound tram, travelling towards Blackhorse Stop

254 At 10:45:12 hrs (Tram 4013 was now stopped at Blackhorse Stop for approximately seven minutes), an inbound tram approached onto Junction A19, travelling inbound towards Blackhorse Stop, see Figure 71.

255 Four seconds later, Tram 4013 departs Blackhorse Stop, with Signal A19 still displaying a Stop aspect. Driver 4013 had not received any instructions from LNMC.

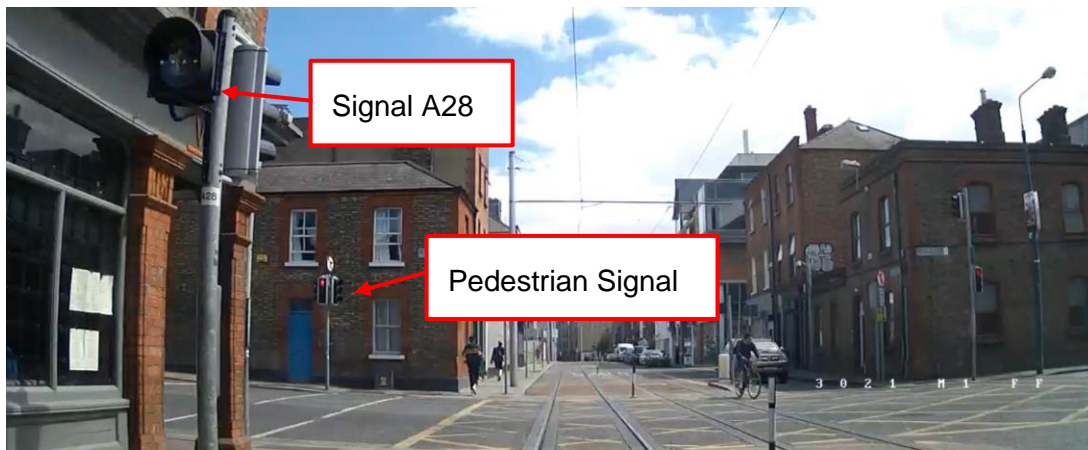
Figure 72 – Tram 3021 stopped at Signal A28

258 On Monday 20th May 2019, Tram 3021, was operating the Tallaght to Connolly inbound passenger service, when it stopped at the signalised junction of Blackhall Place and Benburb Street (Junction A28), located between Museum and Smithfield Stops. As Signal A28 (inbound) was displaying a Stop aspect (Figure 72); the pedestrian signal was also displaying a stop aspect (see Figure 72).

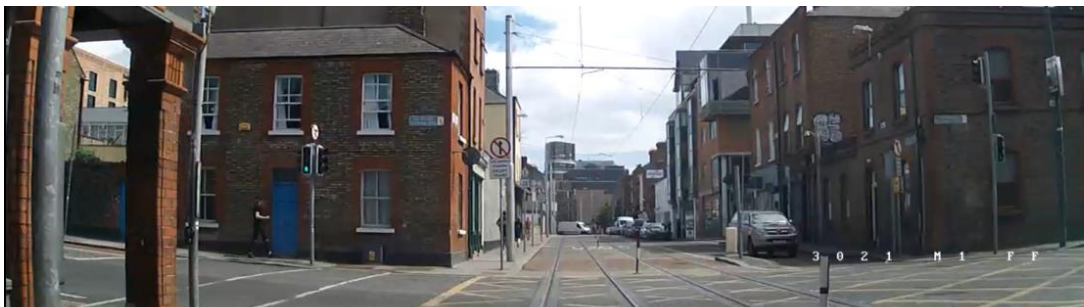
Figure 73 – Pedestrian signal displaying a green figure

259 A few seconds later, the pedestrian signal changed to green (Figure 73), Driver 3021 applied traction and passed Signal A28 on a “Stop” aspect. On realising the signal was at “Stop”, Driver 3021 applied the brake, he did not apply the emergency brake and stopped approximately ten metres past Signal A28 and contacted the LNMC.

260 It was noted that Driver 3021 normally used error prevention techniques during his normal driving duties to prevent SAS SPASs, whereby he would look at a signal, look away and look back again to ensure he had a “Proceed” aspect; however, in this case it was a pedestrian signal that appears to have triggered the movement.

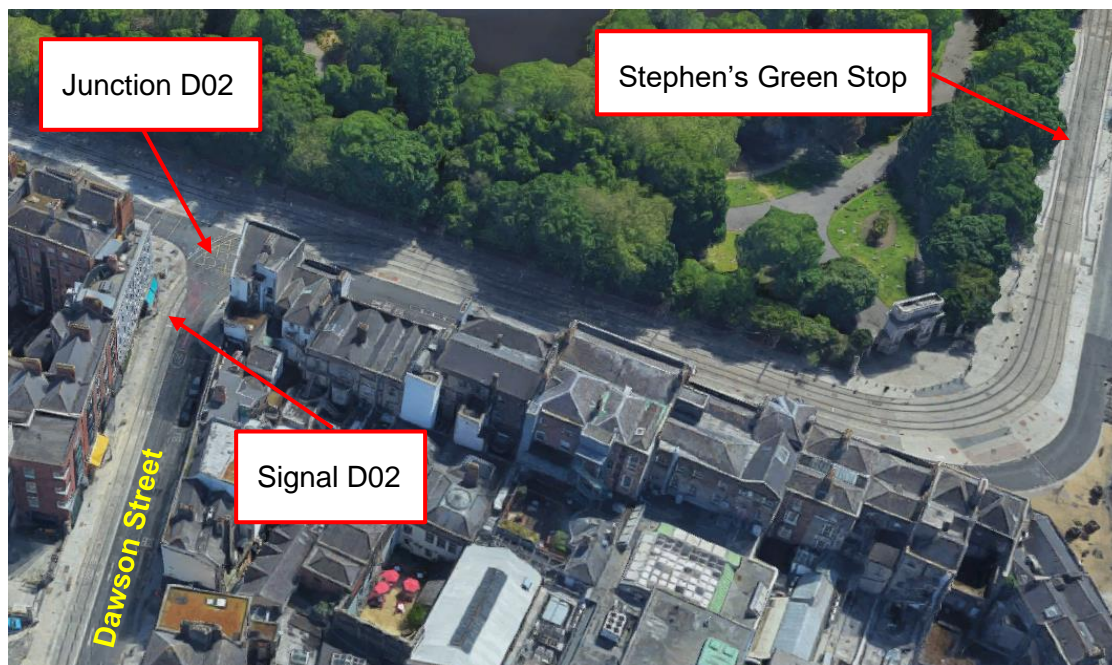
Figure 74 – Location of the incident (images taken from Google)

262 On Sunday 17th March 2019 Tram 5030 was operating the Parnell to Brides Glen outbound passenger service. At Dawson Street, LNMC requested Driver 5030 hold at the platform due to anti-social behaviour at the Stephen's Green Stop (see Figure 74).

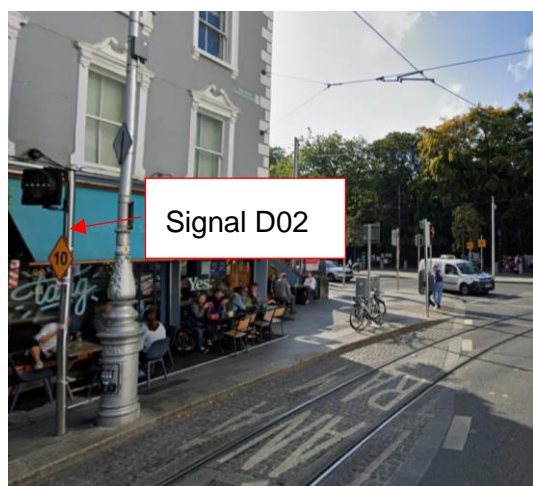
Figure 75 – Signal D02 & Junction D02

263 A few minutes later, LNMC requested Driver 5003 to depart Dawson Stop and continue the service. On approach to Dawson Street/Stephen's Green Junction, Junction D02, tram signal, Signal D02 was displaying a Stop aspect (see Figure 75 and Figure 76).

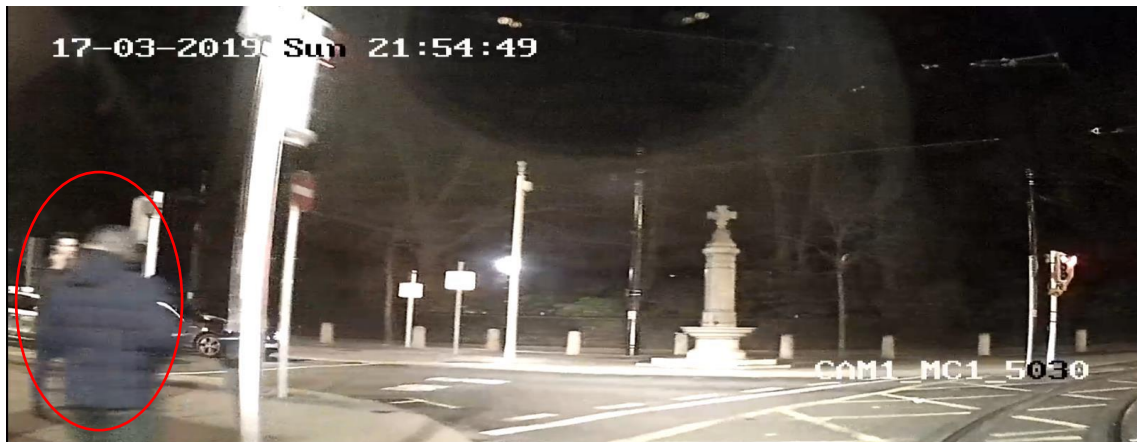
Figure 77 – Travelling onto Junction D02, two pedestrians circled

- 264 Driver 5030 was focused on two pedestrians of the footpath next to Junction D02 and was concerned they were going to walk out in front of the tram (Figure 77 show two pedestrians at the junction).

- 265 At 21:54:49 hrs, Tram 5030 proceeds onto Junction D02, after passing Signal D02 at Stop. A car travelled into the junction in front of the tram causing Driver 5030 to sound the tram horn. Car horns were also sounding. Driver 5030 saw that cars were still travelling through the junction and realised they had been involved in a SPAS and self-reported the incident to LNMC.
- 266 Driver 5030 continued onto St Stephen's Green Stop and contacted LNMC and requested a relief driver to drive the tram back to the depot.
