**Railway Accident
Investigation Unit
Ireland**

INVESTIGATION REPORT

Trend investigation into Signals Passed At Stop on the LUAS network

RAIU Report No: 2022 – R003

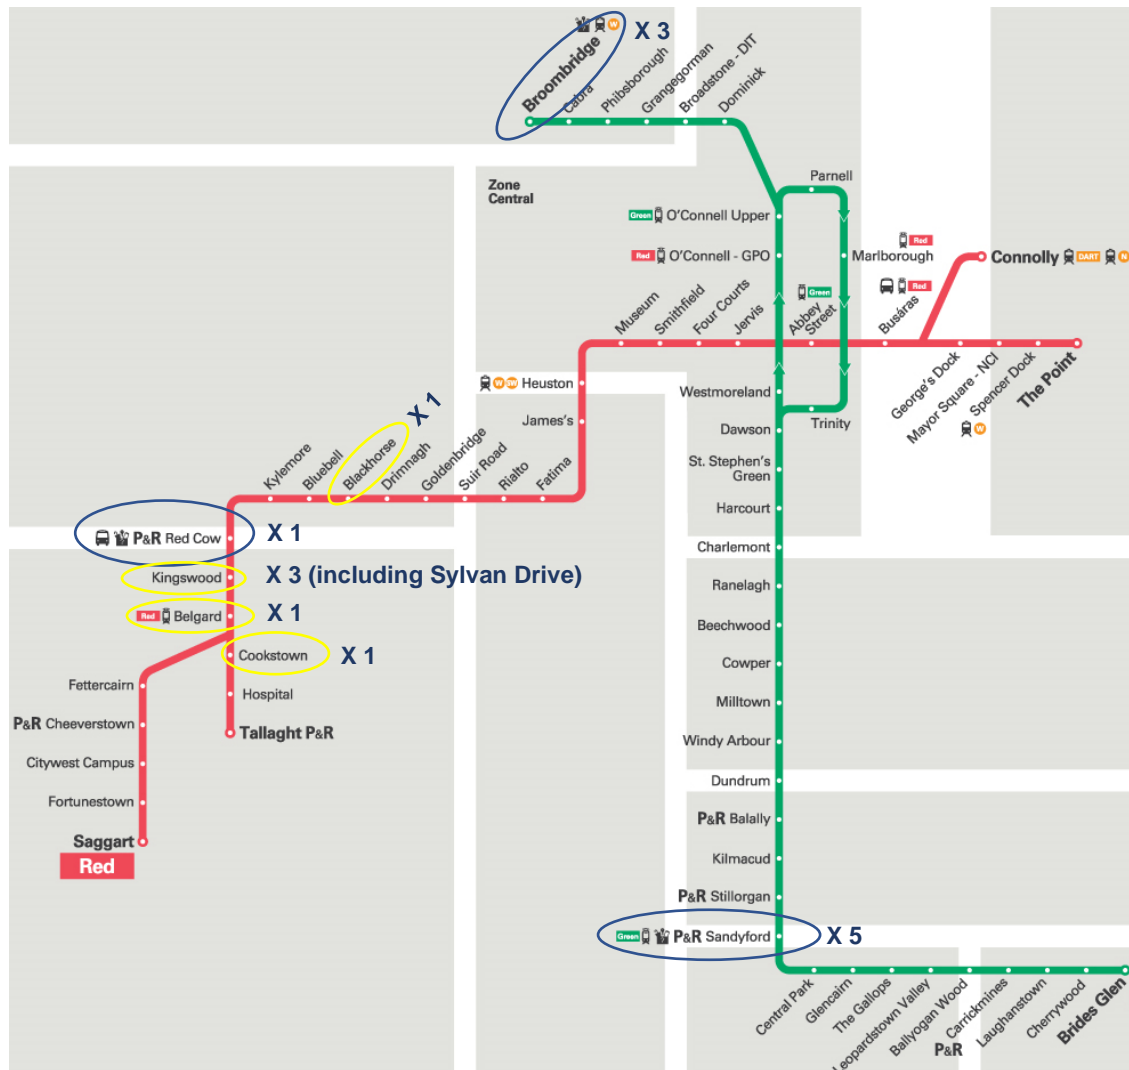
Figure 79 – Locations of SPAS incidents close to meal break locations

292 Of the thirty-six incidents reviewed by the RAIU, fifteen (approximately 42%) occur around the time of scheduled meal breaks; there is some correlation between the meal breaks and the locations where drivers are taking their breaks i.e. Broombridge, Red Cow and Sandyford, this can be clearly seen in Figure 79.
