PART 1 – Occurrence Description

Time & Date	31/01/2025 between 06:45 hours (hrs) and 09:30 hrs
Organisation	Iarnród Éireann Railway Undertaking (IÉ-RU) & IÉ-Infrastructure Manager (IÉ-IM)
Location	Navan Road Parkway
Parties	<p>Other parties involved, directly and indirectly, were:</p> <ul style="list-style-type: none"> • Passengers alighting onto Platform 2, many were secondary school students; • Patrol Driver – Private contractor personnel engaged to open and close and patrol unmanned stations; • Transport for Ireland (TFI) – Reported the incident to IÉ; • Lift Operators – Private contractor personnel located in the security room at Howth Junction Control Centre (HJCC) who operate the lifts.
Incident Synopsis	<p>During the opening of the Navan Road Parkway Station, the platform access gate onto/from Platform 2 to the concourse was closed and locked, preventing passengers leaving Platform 2.</p> <p>Five trains arrived at Navan Road Parkway Station, with numerous secondary school students, alighting, from trains, onto Platform 2.</p> <p>With no other means to leave or access Platform 2, at least thirty-three persons (nine separate instances) subsequently crossed the running lines t

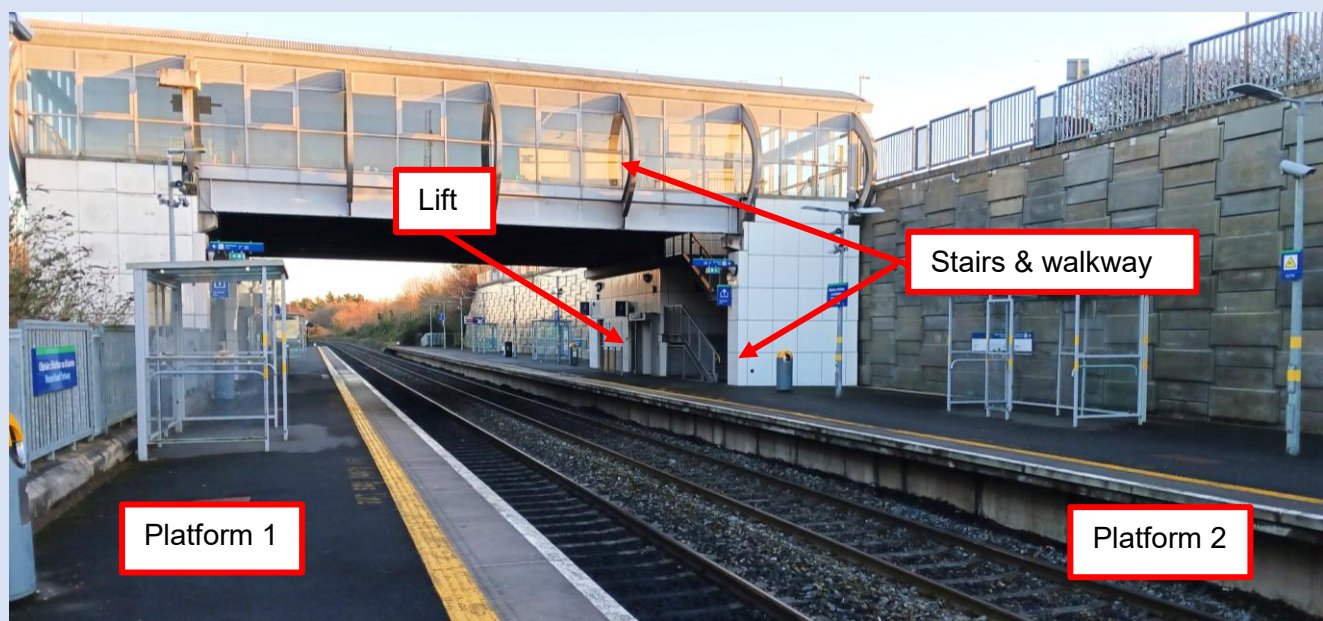
Figure 1 – Navan Road Parkway Station

Navan Road Parkway is a two platform station with access to Platform 2 only available from the combined concourse and bridge via staircase and lift (see Figure 1). Platform 1 is also accessed via the same route, but has an additional access gate provided with a “burst through” mechanism which gives access to the Royal Canal towpath.
