Railway Accident Investigation Unit

INVESTIGATION REPORT

Structural failure of a platform canopy at Kent Station, Cork

18th December 2013
RAIU Report No: R2014 – 005
Published: 7/11/2014

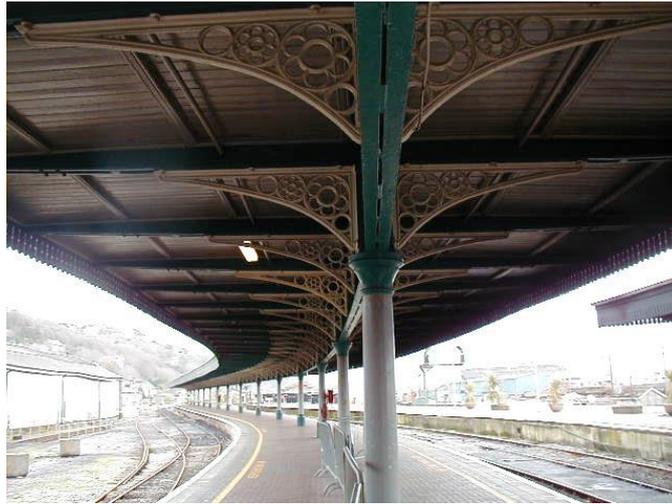
Figure 5 – Canopy above Platforms 1 and 2

- 11 All rails are laid on timber sleepers in Platform Bays 1, 2 and 3 and on concrete through Platforms 4 & 5 (mainline).
- 12 The original construction of the station included a canopy placed over Platforms 1 and 2, shown in Figure 5. The construction of the canopy will be discussed in more detail later in this report.

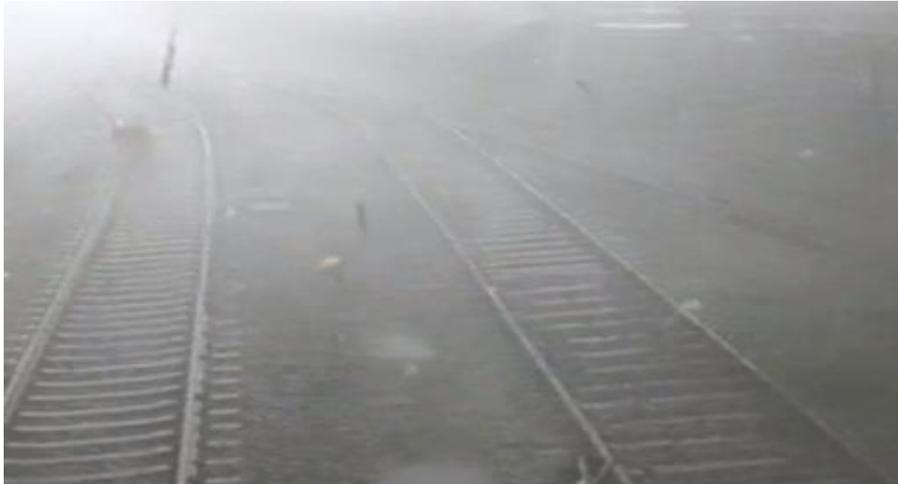
Figure 9 – CCTV from locomotive shed near the location of the accident

28 This is supported by CCTV for the area near the accident which shows consistent rain in the area increased in intensity at approximately 15:01 hrs with persistent heavy rain and gusts of wind of sufficient force to move debris. An illustration of this is shown in Figure 9 which shows the CCTV from the locomotive shed, wood and other debris can be seen being carried by the wind.

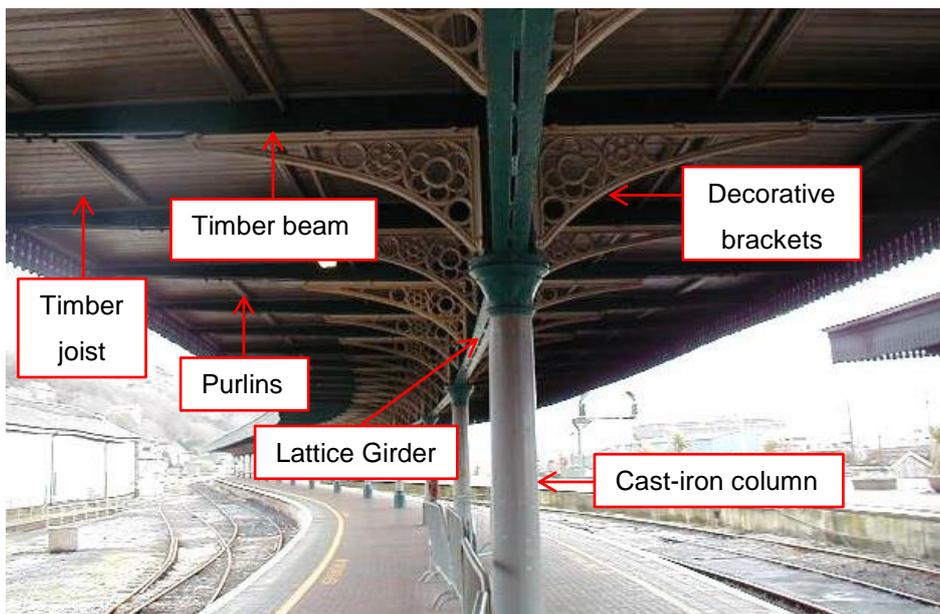
Figure 10 – Canopy above Platforms 1 and 2

32 The canopy was approximately 156.5 m long consisting of a timber roof *cantilevered* over Platforms 1 and 2 which was supported through the centre by a single row of 17 cast-iron columns which were 2.74 m in height. These columns were approximately 10 m apart and braced longitudinally by lattice girders (See Figure 10).

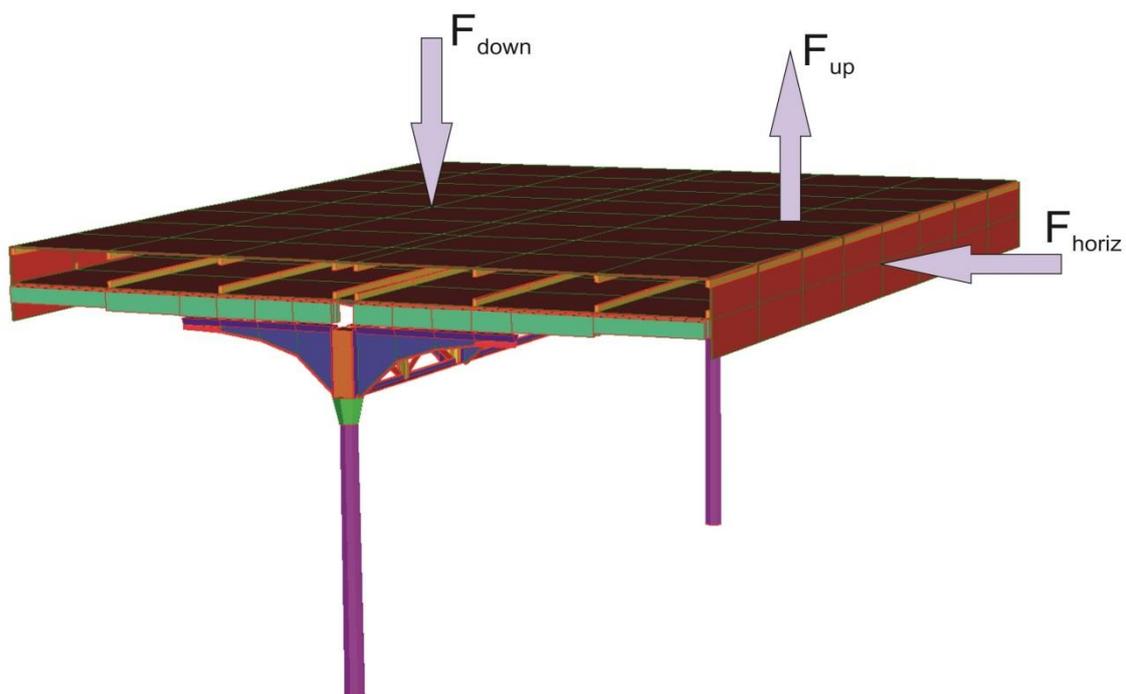
Figure 23 – Single bay used for FE analysis, Fluvio (2014)

70 A single bay of the canopy was created by Fluvio using FE modelling as shown in Figure 23. This element was then used to create a model of the entire structure.

71 A nominal pressure distribution was applied to the plate elements modelling the upper skin of the timber roof (F_{up} and F_{down}) and the plate element modelling the vertical timber sheeting were also subject to a uniform loading ($F_{horizontal}$). This wind pressure was ramped at a rate of 300 MPa/s until the structure collapsed fully.

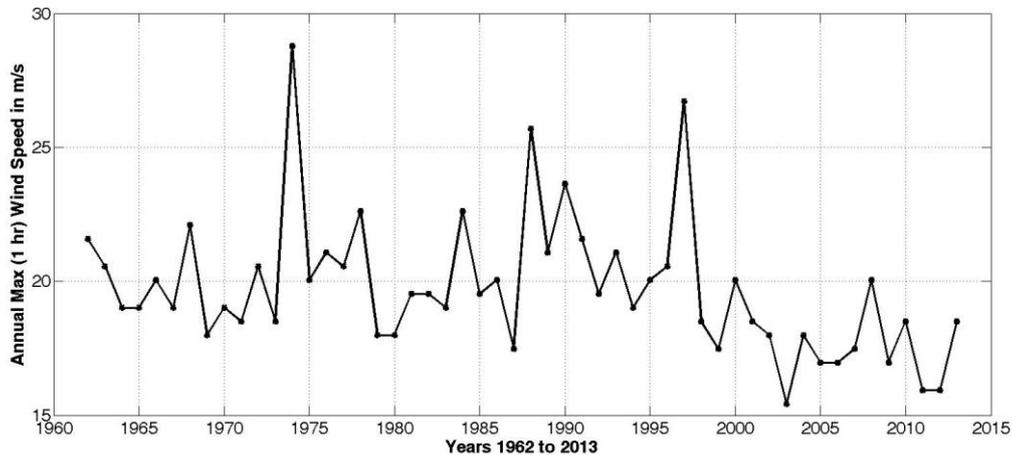
Figure 25 – Annual Maximum (1 hour) wind speed at Cork airport 1962 to 2013, Fluvio (2014)

79 Hourly wind speed data was also analysed by Fluvio to determine the annual maxima and show these as a time series values (Figure 25). The highest recorded hourly annual maximum in the 52 year period for Cork Airport was 28.8 m/s in 1974. By comparison the highest hourly wind speed recorded in 2013 was 18.6 m/s.
