**Railway Accident
Investigation Unit
Ireland**

INVESTIGATION REPORT

**Passenger trap-and-drag occurrence on Luas tram
at Heuston Stop,**

RAIU Report No: 2020 – R001

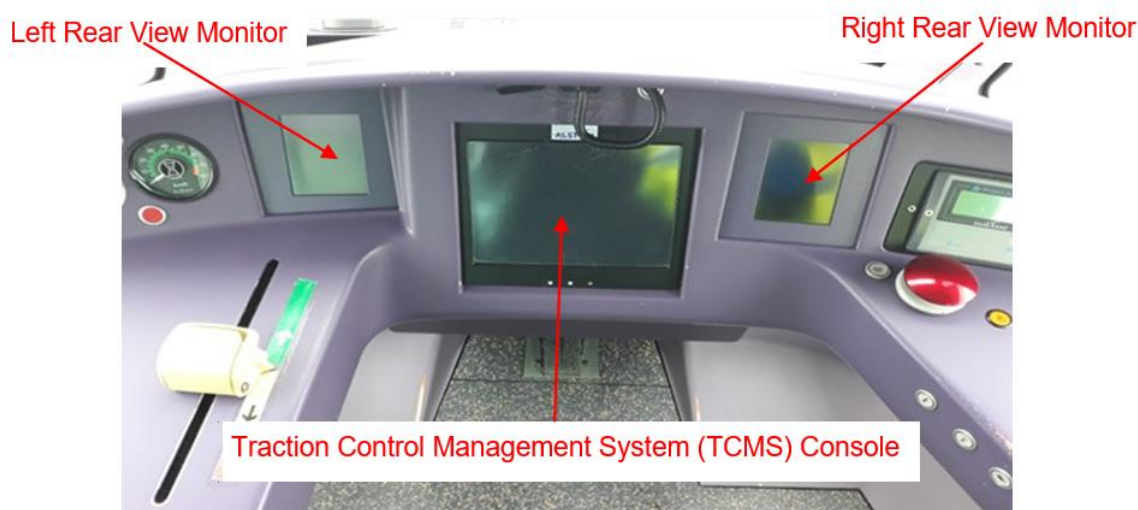
- 43 When a door is open the Door Indicator Light on the driver's console is illuminated and the internal amber lights above the door flash. The driver can view the platform side from the Left and Right Rear View Monitors on the driver's console; the image on the Rear View Monitors on the Red Line are black-and-white whereas the images on the newer fleets on the Green Line are full colour and give a clearer picture.

Figure 4 – Rear View Monitors & TCMS Console

- Safety Recommendation 2020001-03 – TII should conduct a risk-based review on whether the tram fleet operating on the Red Line should be upgraded with coloured rear view monitors;

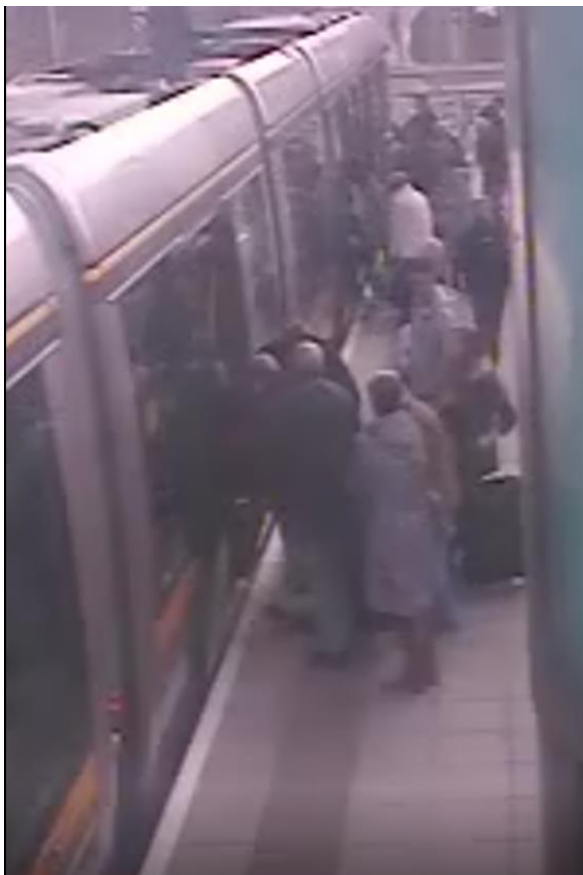
- 75 On the 26th March 2019, Tram 3011 departed Tallaght on route to Connolly. The journey was uneventful up to Heuston Stop with a good volume of passengers exiting and boarding at the stops along the way.
- 76 Tram 3011 stopped on the inbound platform at Heuston Stop at 14:20:57. At 14:20:59 the Driver pressed the left-hand door side selection button and then pressed the door authorisation button to allow passengers to open the doors. All entrance doors were opened by the passengers and the passengers exited and boarded the tram (Figure 11, footage taken from platform CCTV for all the below images).

Figure 11 – Passengers boarding Tram 3011

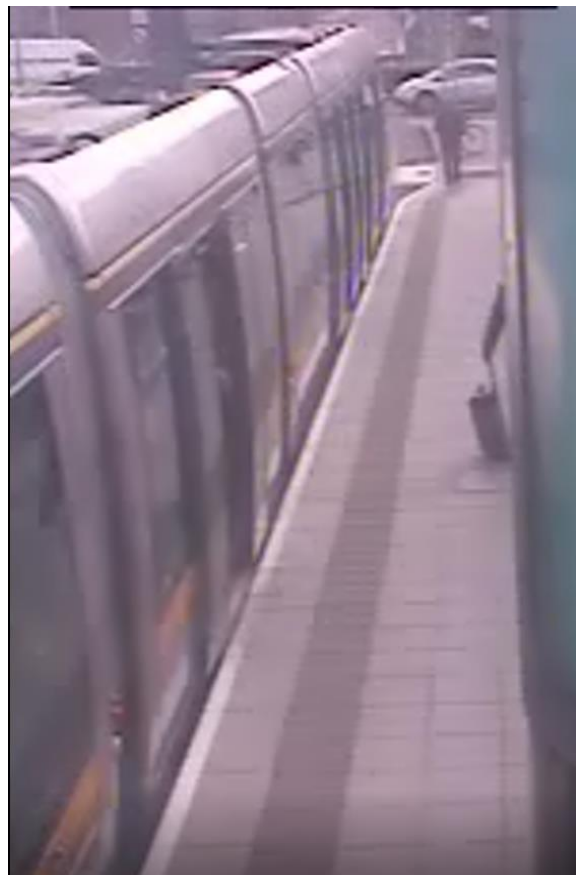
Figure 12 – Passengers clear of doors

- 77 At 14:21:24 the Driver checked the console mounted CCTV monitors, in cab, to ensure all passengers were clear of the doors (see Figure 12), before deselecting the authorisation button, waiting a few seconds and then deselecting the left hand door side selection button.

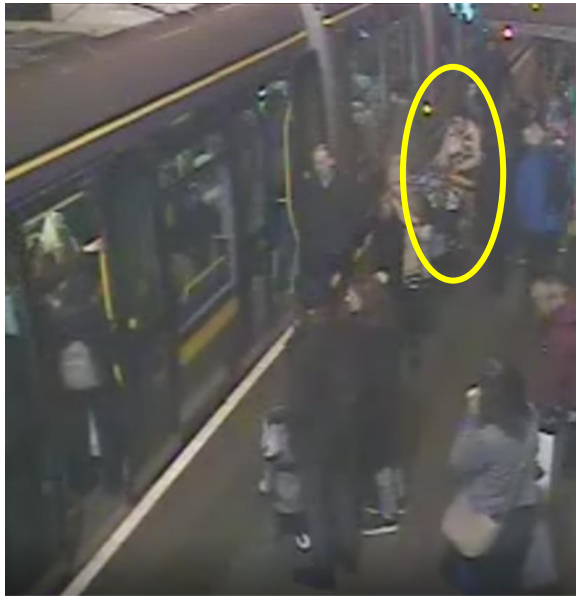
104 The driver checked the console mounted CCTV monitors, in cab, to ensure all passengers were clear of the doors before deselecting the authorisation button, waiting a few seconds and then deselecting the left-hand door side selection button; with the doors beginning to close while a passenger with a buggy (circled in yellow in Figure 19) travels at pace towards the doors.

Figure 19 – Doors begin to close
