# Railway Accident Investigation Unit Ireland

**Annual Report**  
**2019**

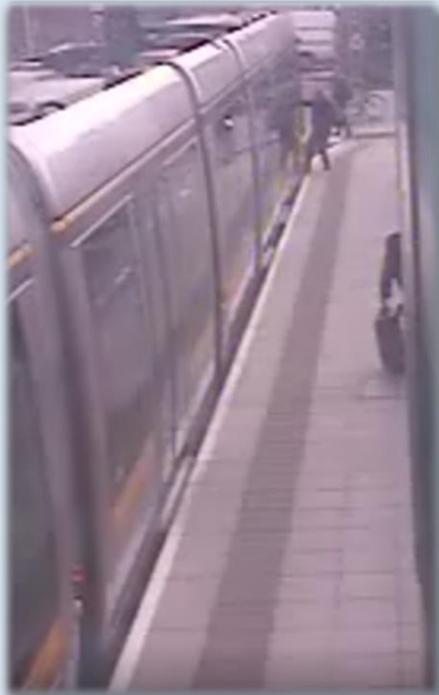
On the 26<sup>th</sup> March 2019, at approximately 14:22 hrs, a male passenger attempted to board inbound Luas tram, Tram 3011, at Heuston Stop. The passenger placed his hand between the door leaf and the door pillar of the rear most entrance door as the door was closing. The passenger's hand became trapped in the door seals. The door obstacle detection system did not detect the presence of the hand as it was less than 10 millimetres (mm); the door operation mechanism allows 10 mm obstacle detection to facilitate door closing.

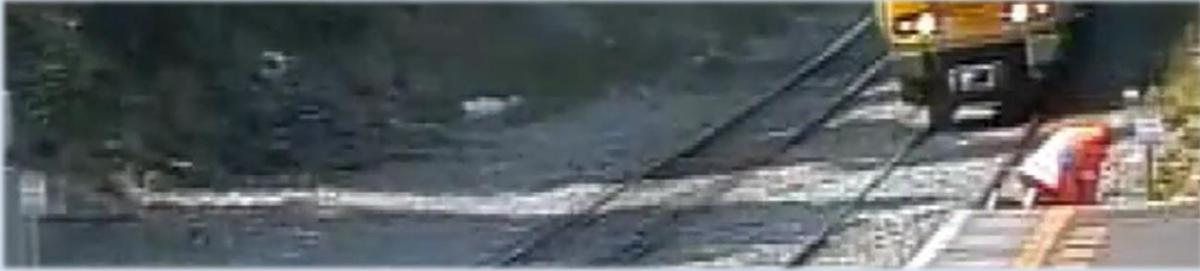
At approximately 09:50:31 hrs, on the 20th June 2019, a member of IÉ-IM's SET Department's staff (to be referred to as SET Worker) accessed the railway line at Rusk and Lusk Station and began walking on the railway line (Up Line). The SET Worker was accessing the railway line to inspect electrical equipment associated with a nearby SET location case.

Seven seconds later the SET Worker sees the 08:00 hrs Belfast to Connolly passenger train approaching on the Up Line and starts to walk towards the other railway line (not occupied by the train, the Down Line). At 09:50:42 hrs, while standing in the middle of the Down Line, he raises his hand above his head to acknowledge the presence of the train, he is not in a position of safety. Two seconds later (09:50:44 hrs) the SET Worker walks across to the Down Platform and leans his elbow down on the platform and raises his other hand to acknowledge the train for a second time, he is not in a position of safety.

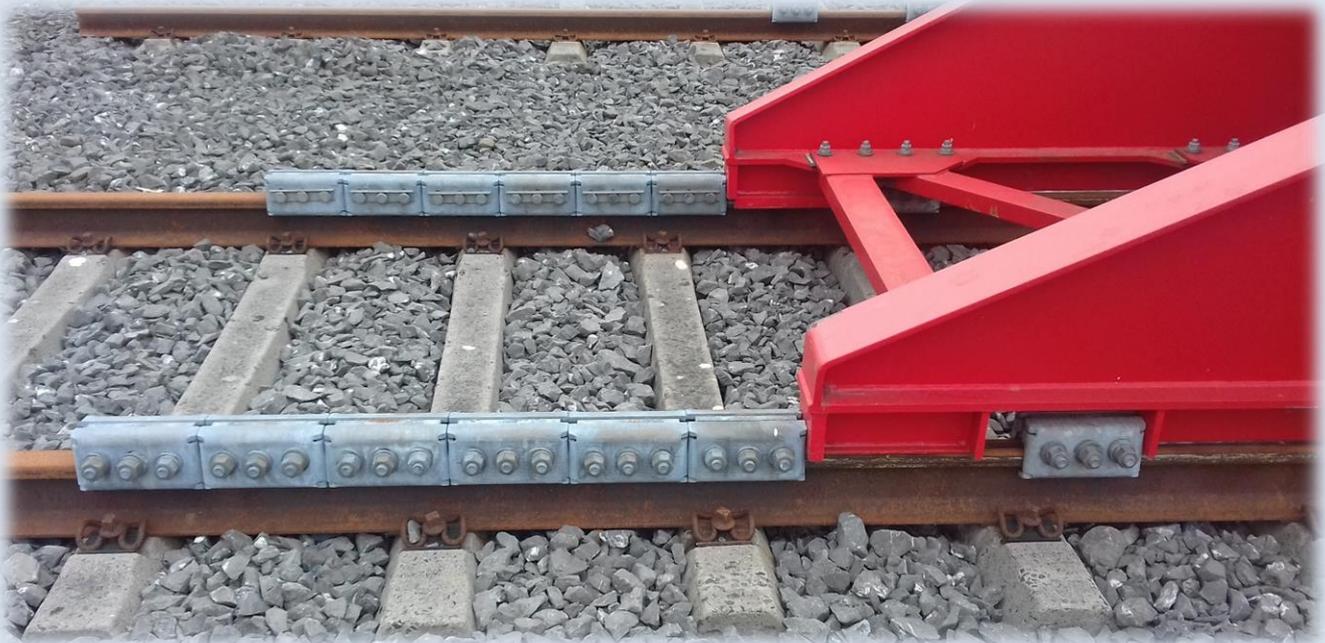
On the 17<sup>th</sup> July 2018 an IÉ ICR, set 16 (ICR 16), was required to be shunted from Road 6B to Road 8 in LTCD to allow maintenance repairs to be carried out on the set following a collision with cattle at Tullamore on 28<sup>th</sup> June 2018.

The CME Driver and Limited Shunter checked the “Handover Notes” and the “Set Stopped – Reason” on the “Daily Production Board” in the Duty Manager’s office in LTCD; there were no restrictions found against ICR 16. The Limited Shunter approached ICR 16 and removed the “Not To Be Moved” Board as there was no identification tag fitted. Initially the Limited Shunter made arrangement for ICR 16 to be hauled into the depot but when the air pressure built up sufficiently the Limited Shunter informed the CME Driver who agreed to drive the unit into the depot. The CME Driver checked the Man Machine Interface (MMI) screen and could see the brakes were isolated on both B-cars (intermediate cars); there was no indication of brake isolation on the two remaining A-cars (cars with driving cabs), and the CME Driver assumed it was safe to drive the train. The CME Driver carried out a Static Brake Test and a Brake Functionality Test utilising the cab brake gauges, while the Limited Shunter carried out an external inspection of the train set. The Limited Shunter found a wheel chock stuck under a wheel and asked the CME Driver to move ICR 16 to allow the chock to be removed. The CME Driver moved ICR 16 and applied the brake, bringing ICR 16 to a stop. The Limited Shunter entered the cab and advised the CME Driver that he would have to pull Points Number 6 (Points 6) in the yard, enroute to Road 15. The CME Driver applied power to ICR 16 and on approach to Points 6 he applied the brake and could feel no retardation i.e. ICR 16 did not slow down. Both the CME Driver and the Limited Shunter made a number of attempts to slow down ICR 16 without success and ICR 16 struck the buffer stop on Road 14 at approximately 14 kilometres per hour (km/h). The CME Driver reported the accident immediately and the relevant parties were informed.

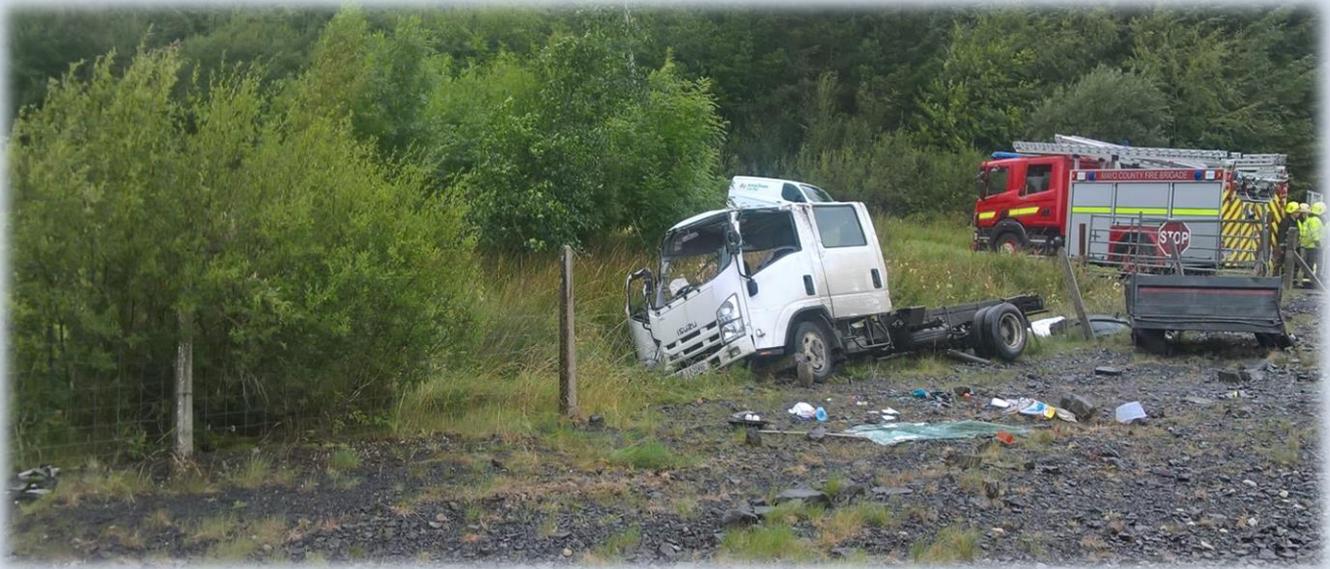
At 08:47:03 hrs a Mayo County Council truck (Truck) approached and drove onto Cartron Level Crossing, IÉ-IM asset number XM220 (LC XM220) and drove onto the Level Crossing. At the same time, the 08:15hrs Ballina to North Wall Dublin goods train, Train K801, was approaching and travelled through the level crossing, striking the truck.

On impact the truck was thrown clear of the train and into the adjacent ditch before coming to a stop, the truck driver was dazed and subsequently left the scene with two colleagues before emergency services arrived and was later treated at Mayo General Hospital. The driver of train was also conveyed to Mayo General Hospital from the scene by ambulance, he was treated for shock.

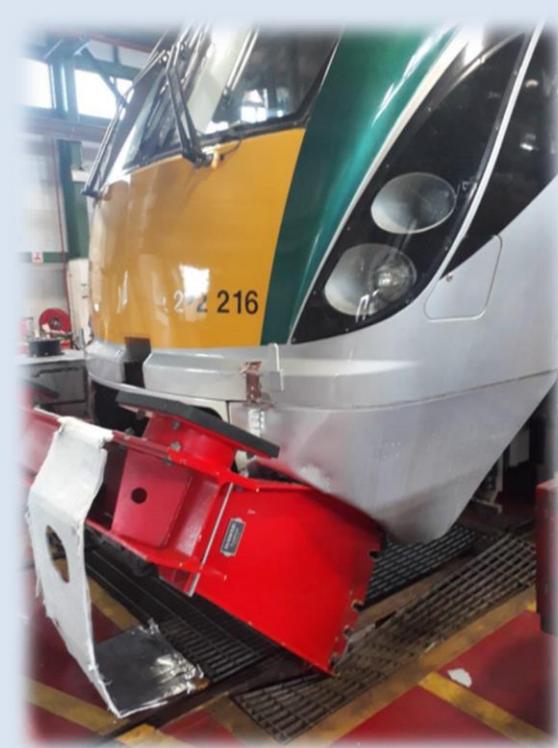
While undergoing maintenance intervention on Pit Road 8, LTCD, ICR 16 was moved approximately 8.25 meters under its own power before colliding with a fixed buffer stop.

The train rode up on, and moved, the buffer before coming to a stop.
