# Railway Accident Investigation Unit Ireland

## Annual Report 2023

## Summary

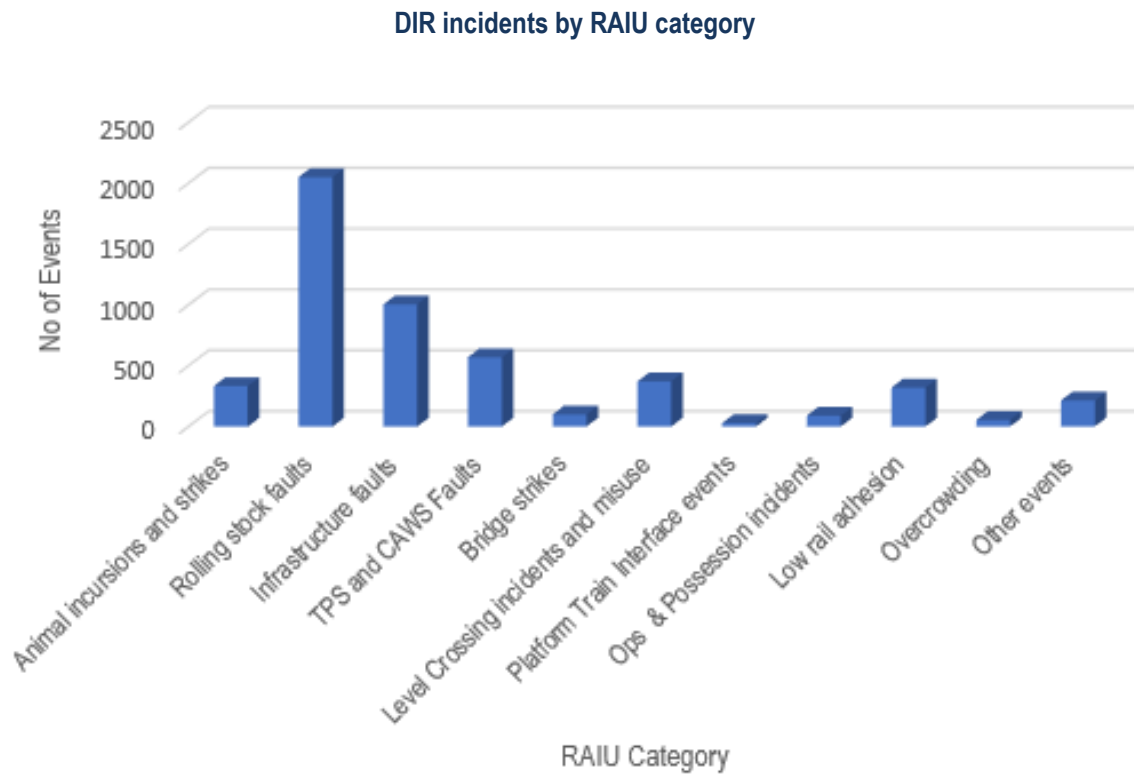
The above figures are presented in the bar chart below:

- 2,050 (40%) rolling stock faults – these can range from minor issues such as faulty air conditioning to more serious incidents such as underframe fires or wheelset damage);

- 1004 (19%) Infrastructure faults – these range from minor infrastructure faults such as reports of poor drainage to broken rails and failing structures;

- 570 (11%) Train Protection System (TPS) and Continuous Automatic Warning System (CAWS) faults – these can range from reports of momentary loss of CAWS code to total failures of the system with almost all system events involve ‘right side’ or ‘fail to safe’. These systems are shared between train and infrastructure and the cause is not immediately apparent at the time of recording in the logs;

- 371 (7%) Level crossing incidents – this includes minor non-compliance events such as level crossing gates left open at user worked unattended level crossings through to damage to crossing barriers, near miss events and collisions between trains and road vehicles;

- 100 (2%) bridge strikes – these range from contact with sacrificial beams or minor contact with the bridge deck, arch or parapet to serious damage resulting in line closure;

- 89 (2%) operational and possession incidents (2%) – these range from events with limited safety impact such as ‘fail to call events’ by passenger trains to incidents such as higher consequence events such as near misses with staff;

- 55 (1%) overcrowding events – these range from discomfort due to limited seat availability through to platform closures for safety reasons;
- 28 (<1%) platform train interface (PTI) events– injuries and mishaps to passengers boarding and alighting from trains not in motion, ranging from staff rendering assistance through to passengers requiring hospital attention.

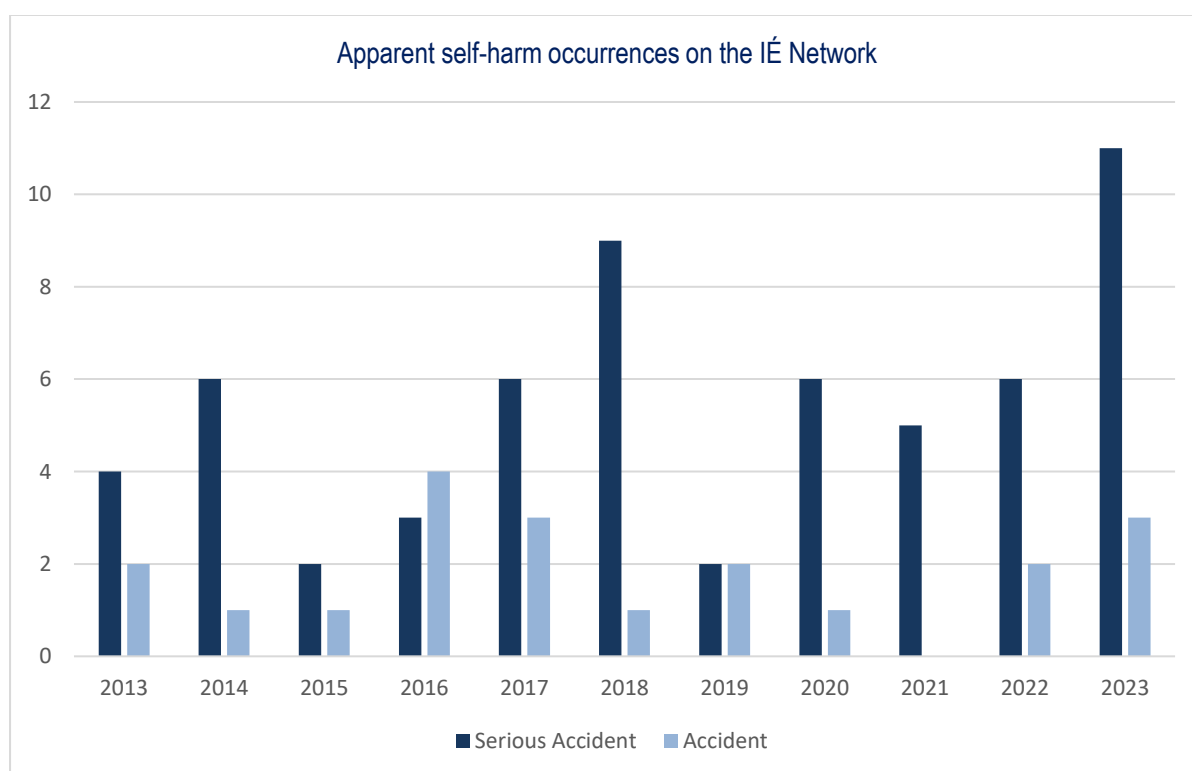
In 2023, there were eleven reported serious accidents (fatalities) and three accidents (non-fatal) as a result of apparent self-harm occurrences on the IÉ network. The figures below indicate no significant downward trend in the number of self-harm occurrences in 2023 and the previous ten year period.

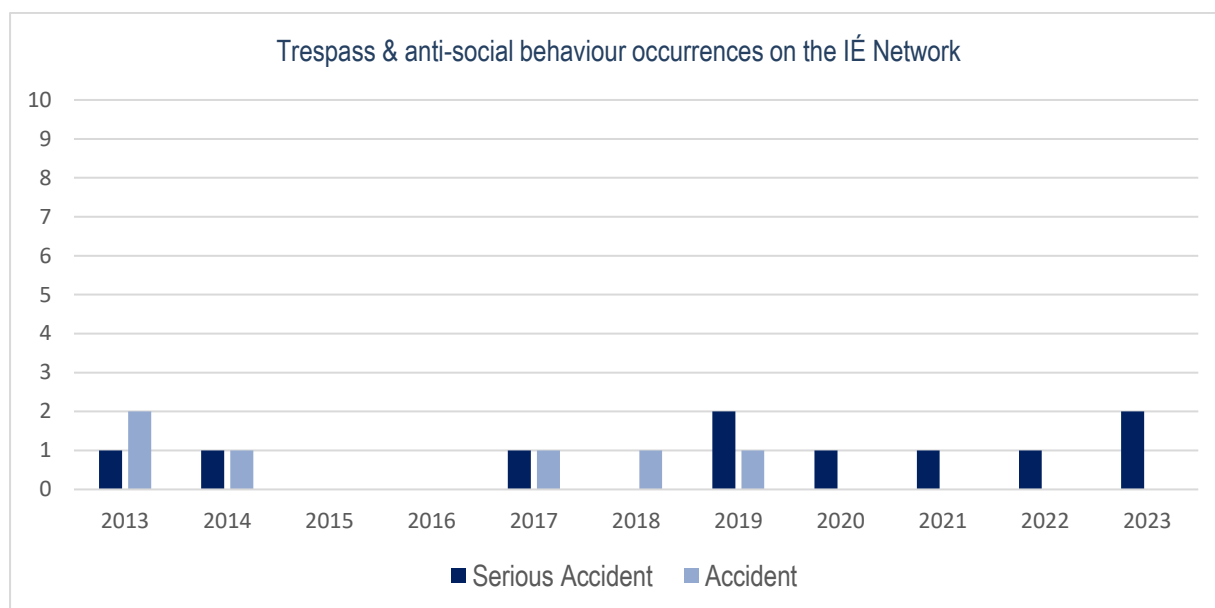
There were two reported fatalities as a result of trespass on the IÉ network in 2023, with the previous six years indicating low numbers.

Note, both 2023 serious accidents involved pairs of people trespassing, resulting in one further injury.

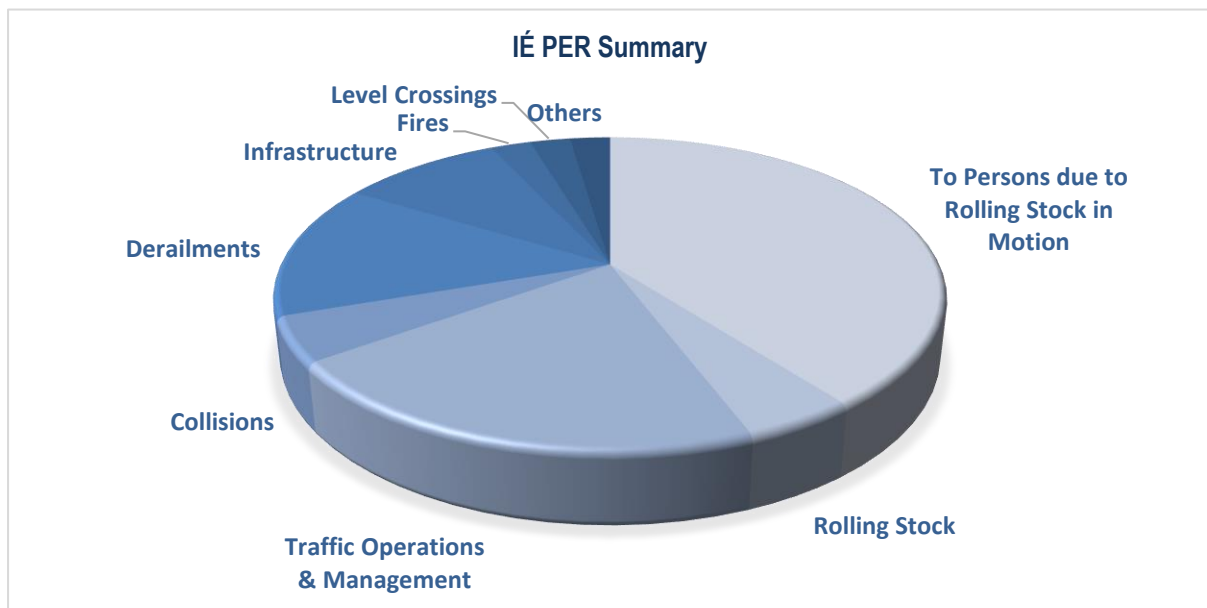
The pie chart below shows the percentages, in terms of categories, of the PERs for IÉ:

- Four infrastructure occurrences (two broken rails and two occurrences of landslip/ subsistence);
- Three derailments (two derailments of locomotives in Inchicore Works sidings and a derailment as a train travelled over an underfloor lathe in Louth);
- One collision (bridge strike);
- Two control, command & signalling occurrences related to CAWS;
- One level crossing accident related to a train collision with a car;
- Two rolling stock incident (one related to the blue door interlock light and one related to wheel turning);
- One fire to a train underframe;
- One other occurrence reported by a driver which was later found not to be a fault.

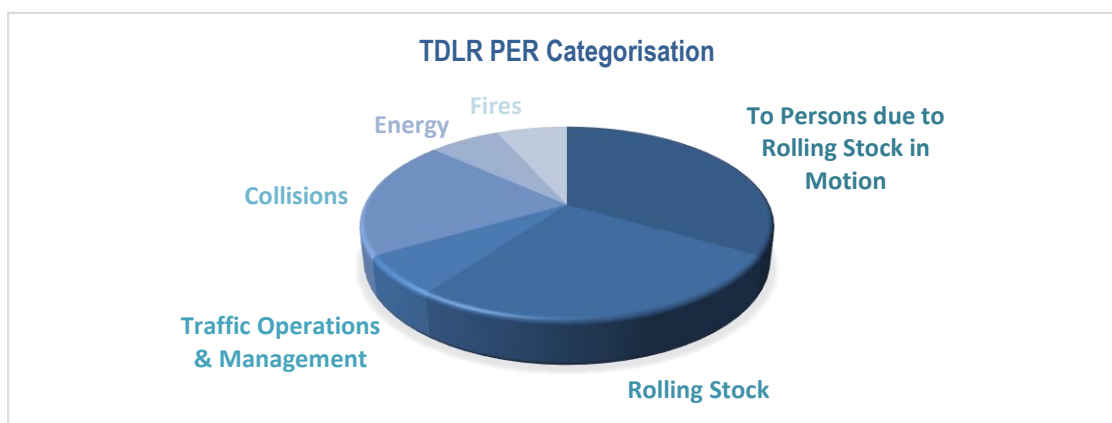
The pie chart below shows the percentages, in terms of categories, of the PERs for TDLR

- Four rolling stock occurrences (related to door obstacle detection, wheel faults, pantograph and underframe);
- Three collisions (two road traffic collisions (RTCs) and one collision of a pantograph striking an overhead line in a depot);
- One traffic operations and management incident (a tram entering a de-energised section in a depot);
- One energy incident (isolation issue);
- One fire (ESS location).

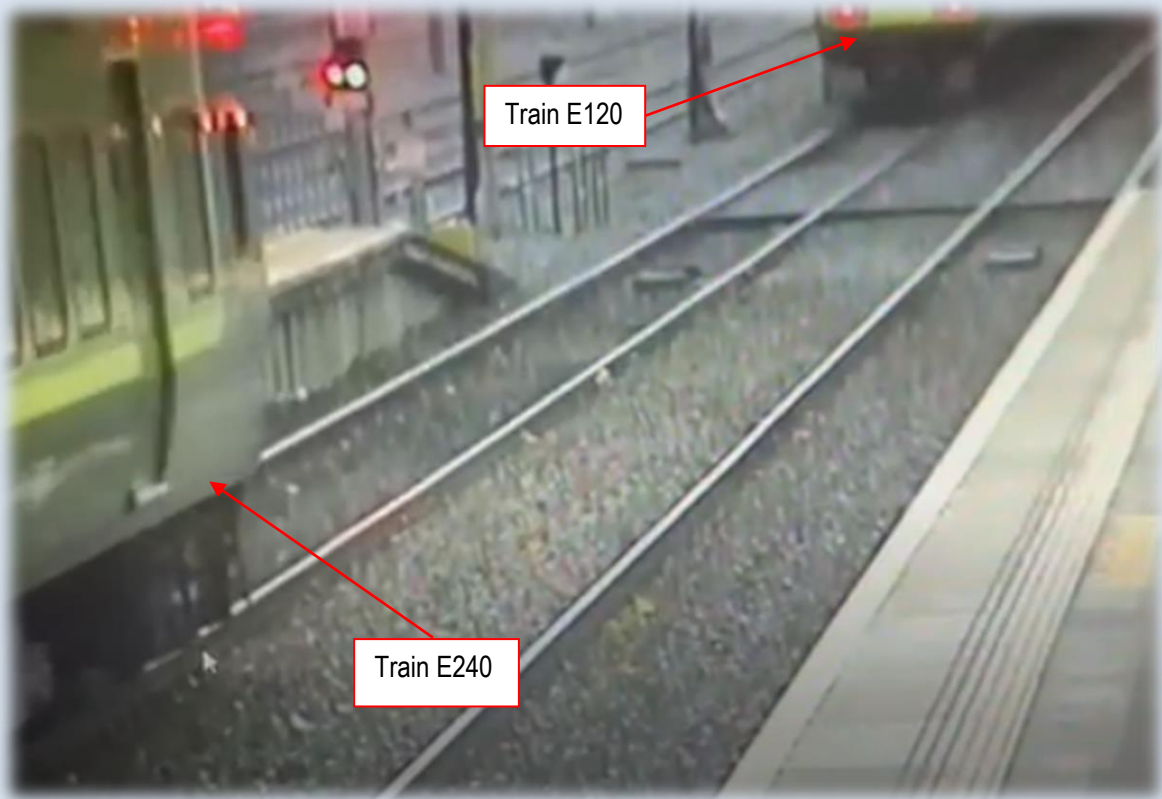
At approximately 15:59 hrs on 7<sup>th</sup> December 2021 the 15:31 hrs IÉ DART passenger service from Malahide to Bray (Train E120) was stopped at Clontarf Road Station Up Platform. The signal to the rear, Signal DN295 was displaying a Red Aspect to protect Train E120. At around the same time, the 15:40 hrs DART passenger service from Howth to Bray (Train E240) was approaching Signal DN287 at Clontarf Road Station.

The train's speedometer and On Train Data Recorder (OTDR) showed the train was travelling at 79 kilometres per hour (km/h); the permitted line speed for the section is 75 km/h and reduces to 30 km/h on approach to Clontarf Road Up Platform. The OTDR shows the train braking system initiated an Automatic Train Protection (ATP) penalty brake as the train was travelling at a speed (79 k/h) greater than the target speed (30 km/h). The ATP brake application, in trying to reduce the train speed, resulted in the train's Wheel Slip Protection (WSP) system activating to prevent the wheels from locking up and sliding on the degraded railhead caused by Storm Barra.

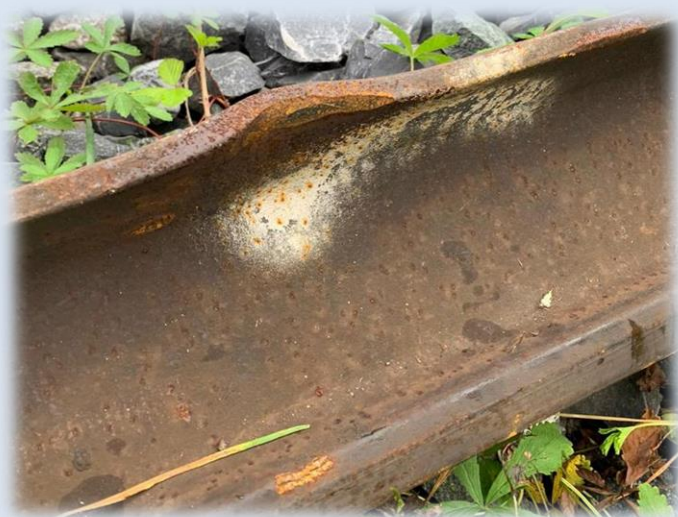
At 23:00 hrs on the 26<sup>th</sup> August 2021 a work detail incorporating: three IÉ-IM CCE staff (Engineering Supervisor (ES), Person in Charge (PIC) and General Operative (GO)) and eight contracted staff, met for a safety briefing at a works compound adjacent to the old Curragh Station, County Kildare. The work scheduled by the CCE Infrastructure Department was to replace a defective nine metre (m) section of rail. The work crew were briefed by the ES on their duties for the

night and given site safety information including that the work would be under an Absolute Possession (T3 Possession). After the briefing, the ES and GO, followed by the contractors, drove to the access point close to the intended work site. They waited a few minutes until the ES confirmed the last timetabled train passed the worksite (although there was an unscheduled train to pass which was unknown to the ES), and then the ES stated that they were “good-to-go”. The T3 Possession had not been prepared or granted at this stage i.e. the line should not have been accessed and no work should have commenced. When the work detail arrived at the site of the defective rail, the GO started to loosen the bolts which fix the rail to the concrete sleeper, while one of the contracted welders started digging the ballast out from around where the clamp was to be placed (the clamp is part of holding gear equipment that is clamped to the rail during rail replacement works). The two other contracted welders started to attach the clamp to the Down Leg of the Up Line. The contractor that was digging the ballast, turned to put down his shovel, when he saw the lights of an approaching train and shouted “train on” and all staff quickly moved to a position of safety.

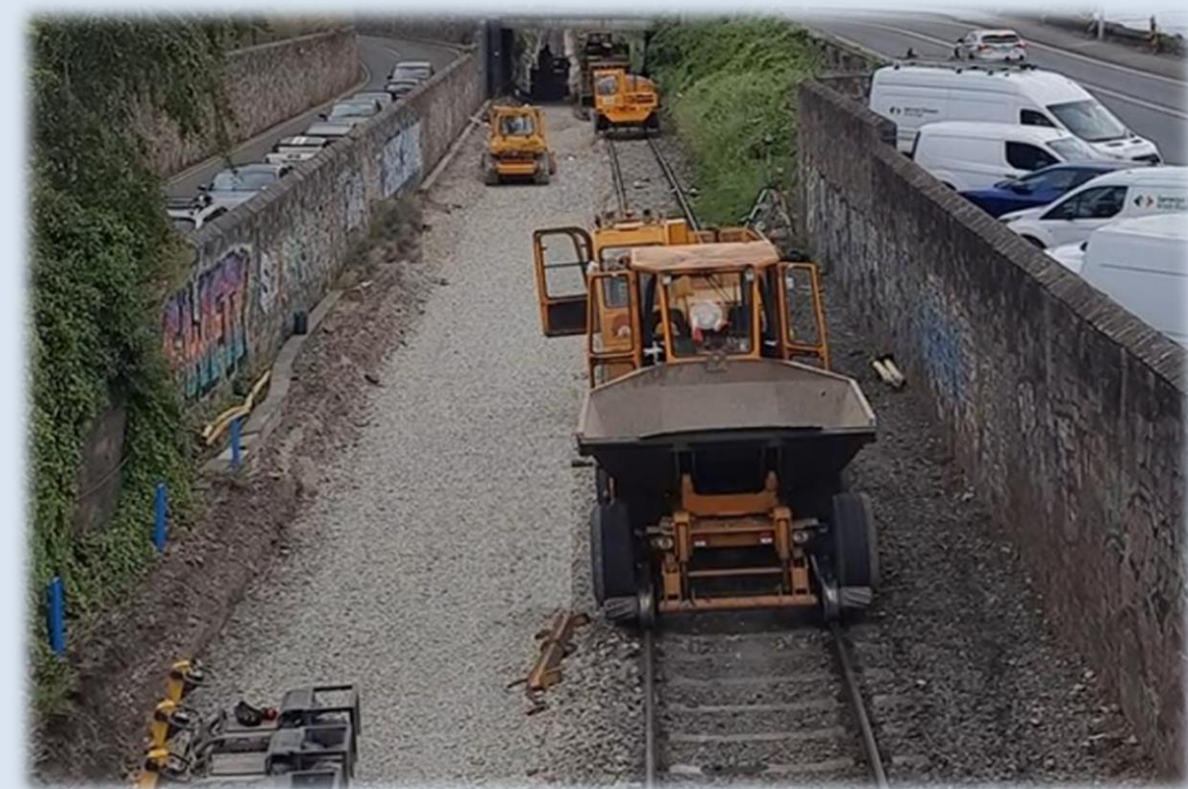
On the 6<sup>th</sup> July 2020, there were four separate worksites within a T3 Possession in which engineering works on the Cork-Cobh-Midleton lines was being undertaken. The work being carried out in worksite one entailed track panel relaying and steel bridge repairs between Woodhill and Tivoli.

There were thirteen items of hired plant and machinery in the worksite, including six RRV Dumpers, which were used for drawing stone from a lineside stockpile at Tivoli access point on the Cobh side of the Up Line. On completion of the loading movement the RRV Operators (RRVOs) awaited directions from the Person In Charge (PIC)-RRV to tip the stone over the course of the track relaying works.

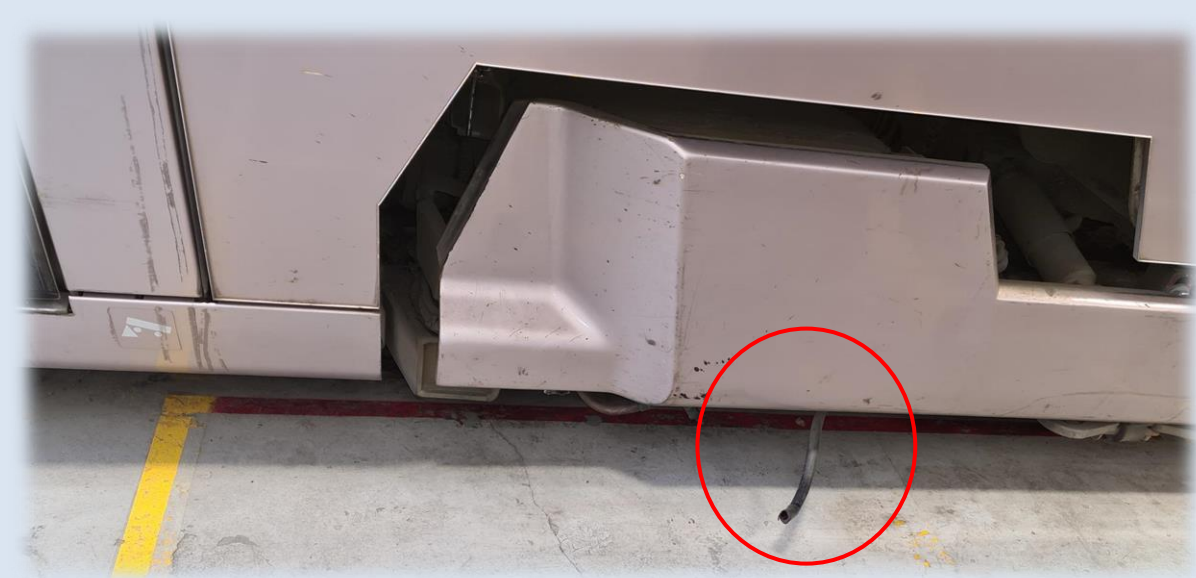
At approximately 08:08 hrs on 25<sup>th</sup> October 2022 Tram 3012 was departing Connolly Stop, when the driver of Tram 4012 (Driver 4012), approaching Connolly Stop in the opposite direction, saw what they thought was a hose protruding from the underframe of Tram 3012.

Driver Tram 4012 contacted the Traffic Supervisor responsible for the Red Line in the Luas Network Management Centre (LNMC) who in turn contacted the driver of Tram 3012. The Traffic Supervisor advised the driver of Tram 3012 (Driver 3012) to continue in passenger service to the Red Cow where the service would terminate and transfer into the Red Cow Maintenance Depot.

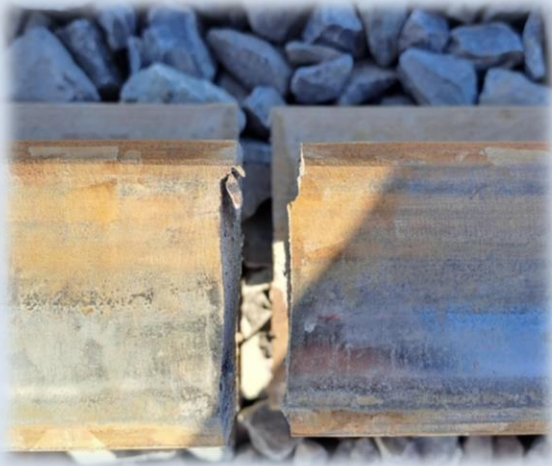
### Broken rail, Newbridge, Kildare, 23<sup>rd</sup> February 2023

On the morning of the 23<sup>rd</sup> February 2023, as the 07:00 hrs Newbridge to Grand Canal Dock passenger service (Train P402) travelled on the Up line near Newbridge, Co Kildare; the driver saw an abnormal Continuous Automatic Warning System (CAWS) downgrade on the train's in-cab display and reported it to the Mainline Signalman. A number of other drivers reported the same abnormal downgrade at the same location.

The SET Department were advised, and an SET member of staff was dispatched to site to investigate and discovered a broken rail.

The broken rail was found to have fractured through a flash butt welded joint. The rail had been installed on the 28<sup>th</sup> January 2023 (five days earlier). The flash butt welding of the rail had been carried out off-site at IÉ-IM's Portlaoise Rail Welding Plant.

| Reporting Railway Body* | Date of occurrence | Location of Occurrence | Classification of Occurrence | Classification subset | Summary | Fatalities/ Injuries |
|---|---|---|---|---|---|---|
| IÉ-IM | 23 February 2023 | Newbridge, Kildare | Incident | Infrastructure | A broken rail (flashbutt weld) was found after the Signaller had a number of reports, from drivers, that there was an issue with the CAWS (see page 48). | 0 |

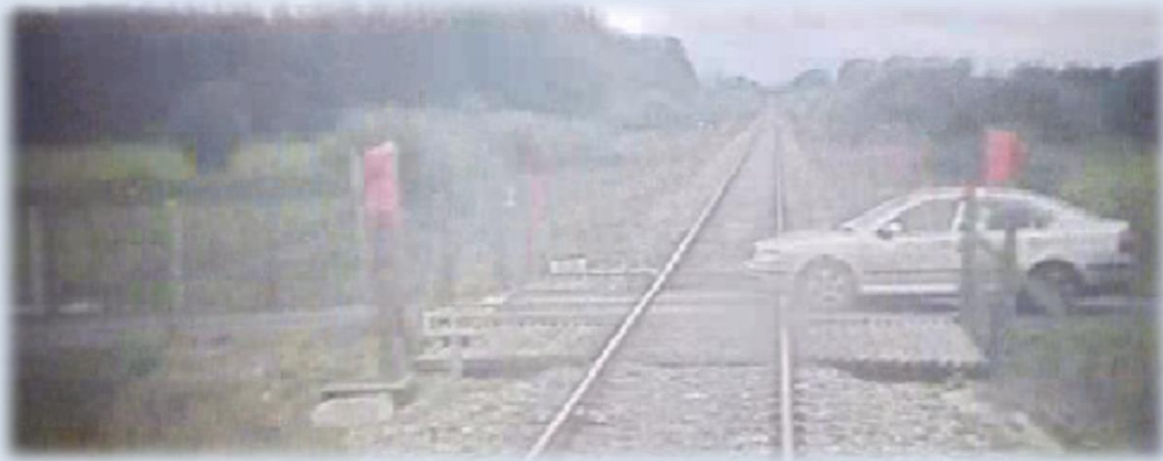
### Collision between a car and a train at Prendergast's Level Crossing (XM190) Mayo, 9th September 2023

At approximately 15:15 hrs on the 9<sup>th</sup> September 2023 the 12:45 hrs Heuston to Westport passenger service was approaching Prendergast's Level Crossing, located between Ballyhaunis and Claremorris, when, at the same time a 2009 silver Skoda Octavia was approaching the level crossing, by road.

The gates at the level crossing had been left open to road traffic by a previous user, and the car did not stop on arriving at the level crossing.
