Railway Accident Investigation Unit Ireland

Annual Report 2024

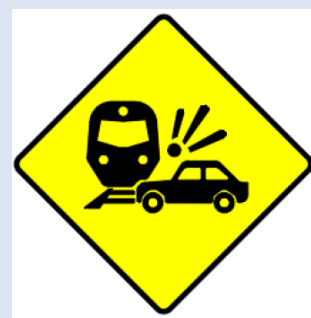
A new sign is currently being trialled at two OP Type level crossings. This new sign, Sign W126, depicts a train striking a car, with a “collision” element, clearly illustrating the hazard (i.e. live railway) and the severity of the hazard if the sign is not adhered to the warning (i.e. being struck by a train). Initial feedback, from level crossing users, is in favour of the proposed new sign, Sign W126 (see pictorial on right).

- Safety Recommendation 2024003-01 – The Department of Transport should continue to trial the new design sign (Sign W126), in consultation with the relevant stakeholders, with a view to replacing Sign W121. The RAIU maintain that the advance warning signs on the approaches to OP Type level crossings should portray the hazard (i.e. the road user is approaching a live railway) and indicate the severity of not adhering to the warning (i.e. possible collision with a train);
- Safety Recommendation 2024003-02 – IÉ-IM should replace their "Warning Trains" sign, located at OP Type level crossings, to the new proposed advance warning sign (Sign W126), once included in the Traffic Signs Manual.

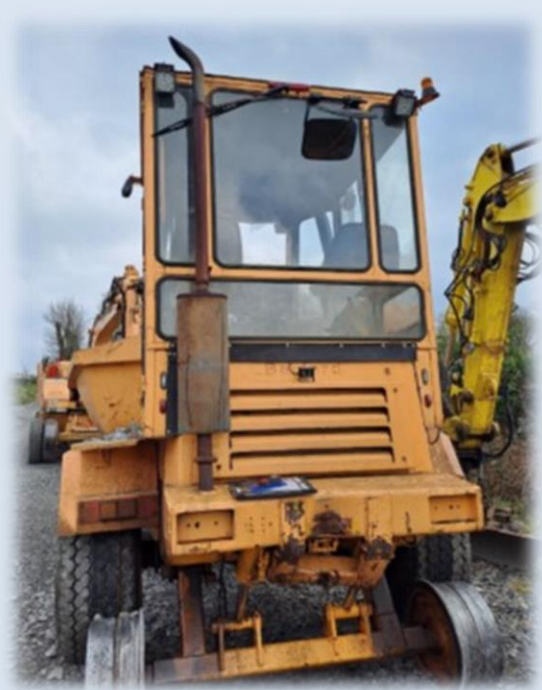
One RRV Excavator (RRV1) and two RRV Dumpers (RRV2 and RRV3) and one tracked excavator were being utilised for the ballasting works. The work involved moving ballast from the access point at Over Bridge Galway (OBG) 159 near 116 ¼ MP to 119 MP.

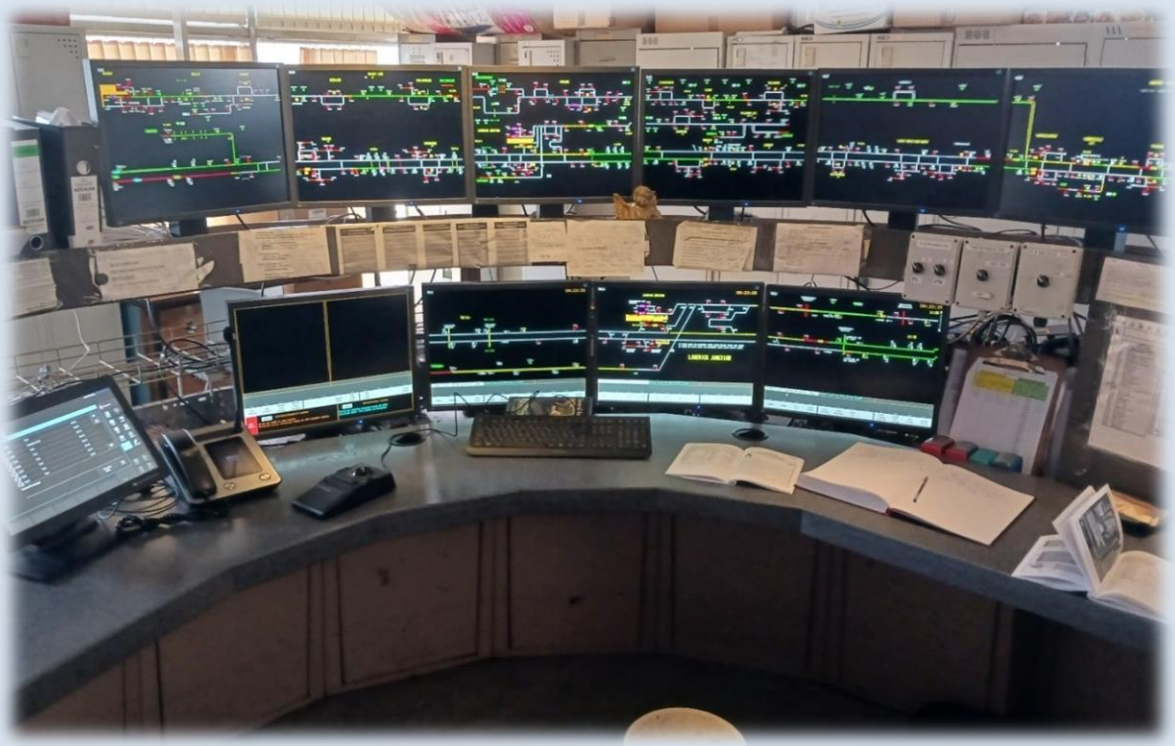
IE operational irregularity at the 70¾ MP, near Ballybrophy, on the Cork mainline, 28th March 2024

At 14:00 hrs on the 28th March 2024, the 13:00 hrs Dublin Heuston to Cork passenger service (Train A214) travelling on the Down line between Ballybrophy and Lisduff, County Laois, activated a HABD at the 68 ½ MP. The Controlling Signalman and Communications Signalman on the Mainline CTC Workstation heard the alarm and responded.

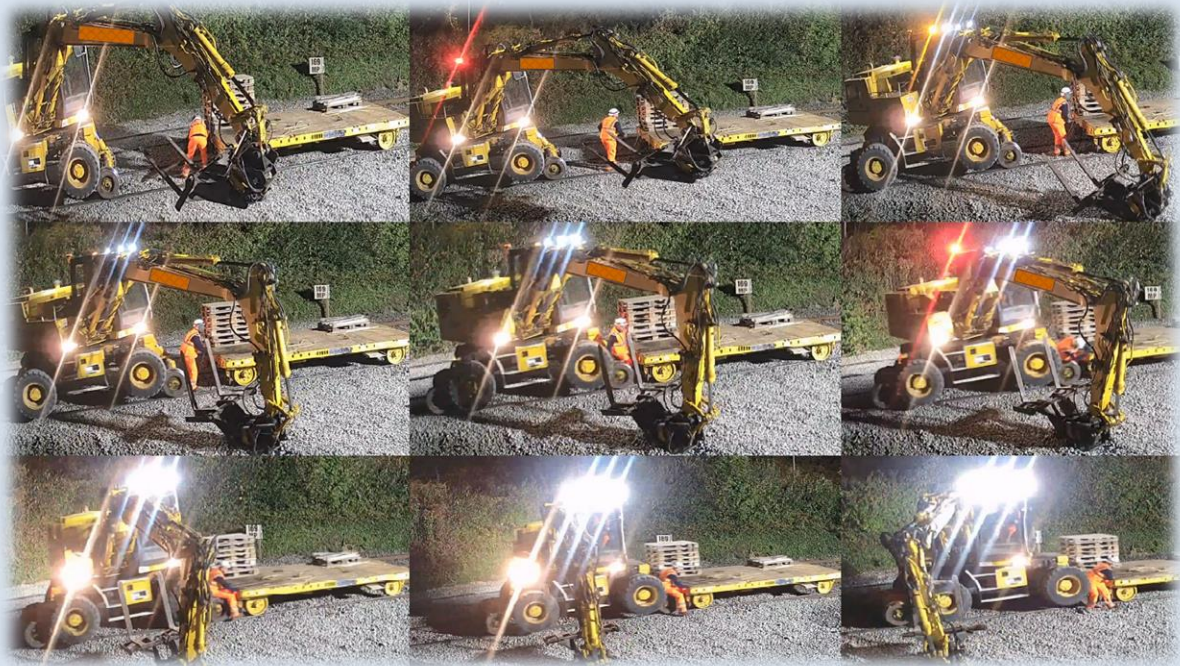
IÉ collision between a RRV and a member of IÉ staff, North Esk, Co. Cork, 10th September 2024

On the 10th September 2024, during a T3 Possession on the Cork to Cobh and Midleton Lines, an IÉ-IM member of staff from the CCE Department was undertaking the role of PIC-RRV.

At approximately 02:50 hrs the PIC-RRV was unhooking the draw bar from the Rail Trailer and clearing some scrap pallet timber from the Rail Trailer.
